# scopito

Report date:  
Mar 16, 2020

Type:  
Power Line

Company:  
Scopito Demo 1

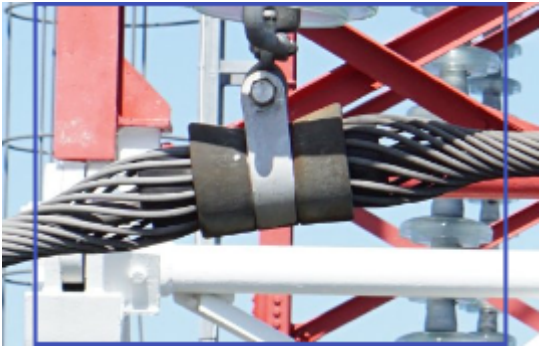
| Id | Severity | Issues | Comments | Page |
|---|---|---|---|---|
| 882879 | ? | POI | AGS Clamp | 5 |

882879 Point of interest POI

Inspector:  
AGS Clamp

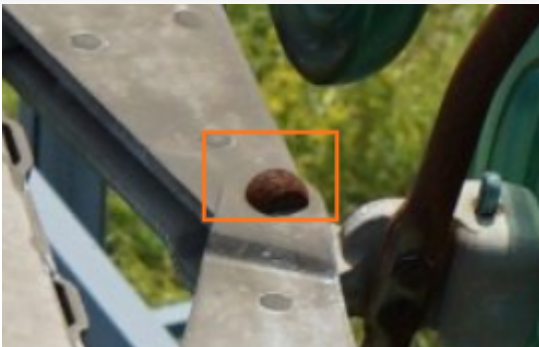
882892 Severity: 2 rust on bolt

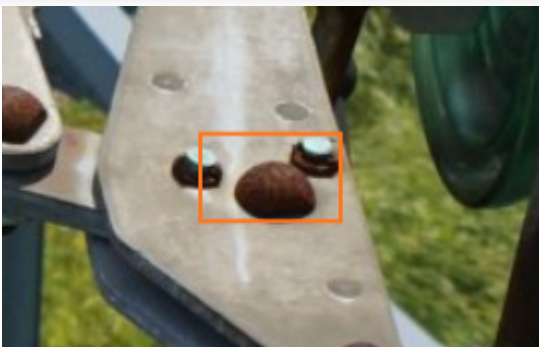
882893 Severity: 2 rust on bolt

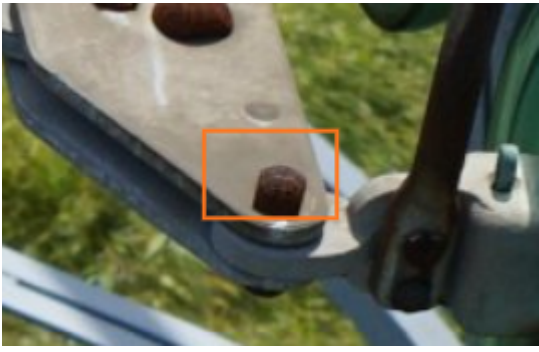
882894 Severity: 2 rust on bolt

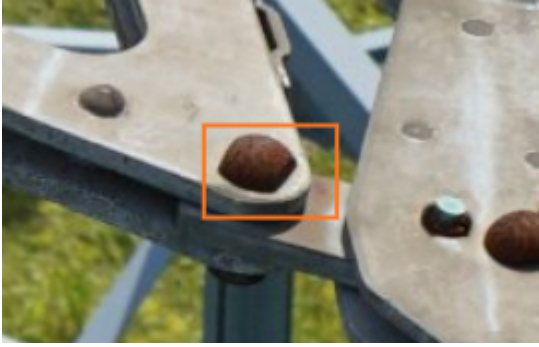
882895 Severity: 2 rust on bolt
