**Fjordkrydsning maste 28-31-
Demo**

Type:
Power Line

Detailed drone inspection of a 400KV river crossing.

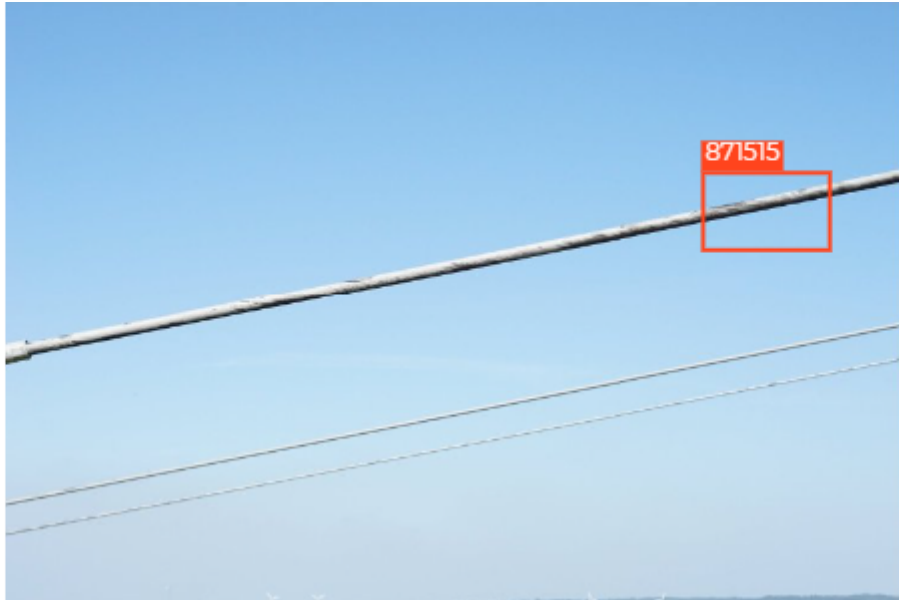
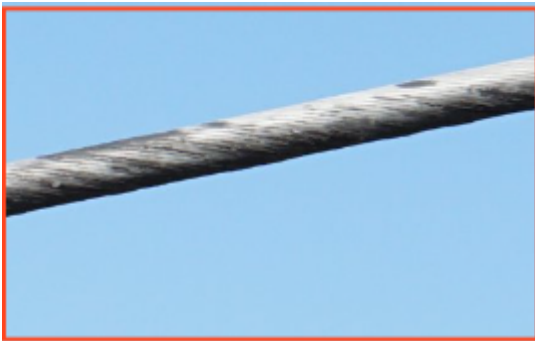
File name:	DSC06417.JPG	Altitude:	20.16m
Date taken:	Aug 6, 2015 2:10:08 PM	Heading:	North (345.31°)
Position:

871515 Severity: 4 Corrosion

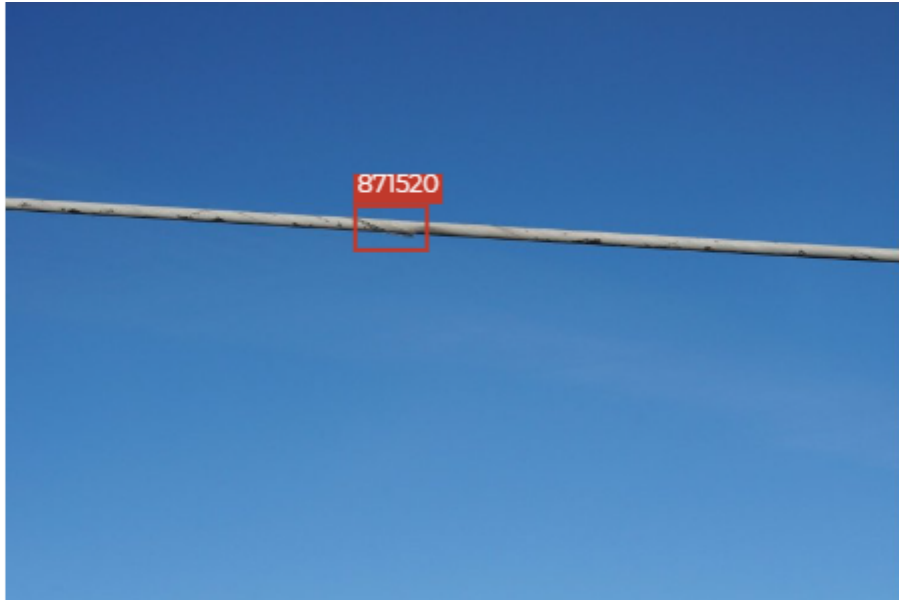
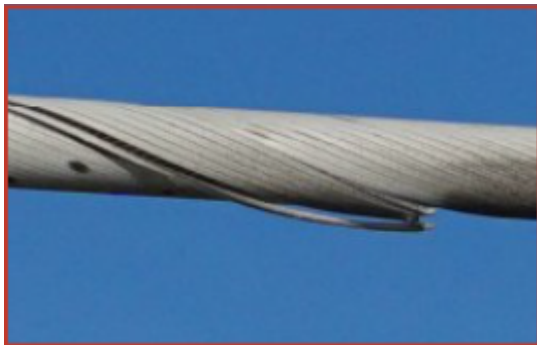
File name:	DSC2819.JPG	Altitude:	70.49m
Date taken:	Oct 20, 2015 11:09:05 AM	Heading:	North (340.12°)
Position:

871520

Severity: 5

Lightning strike

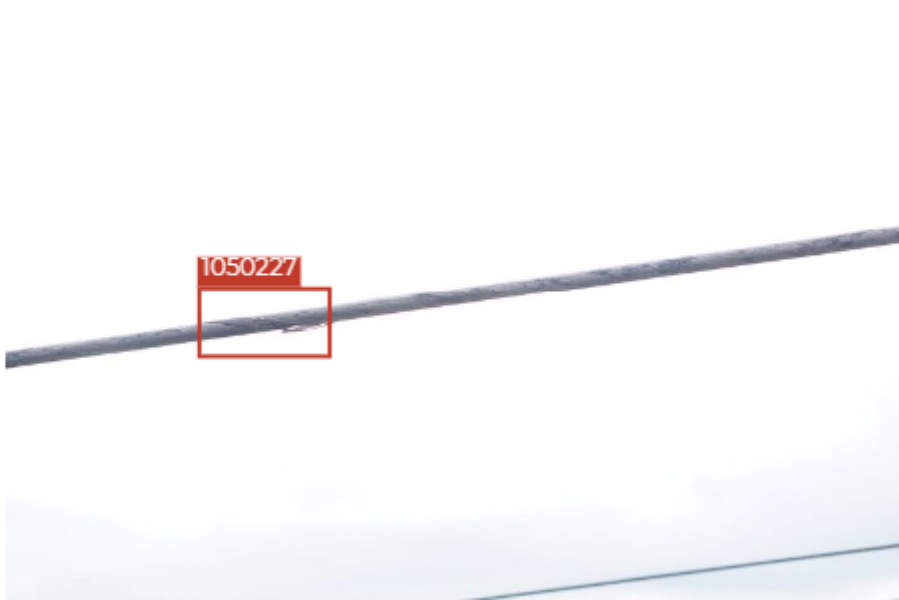
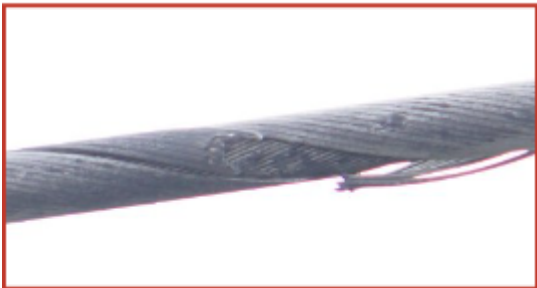
File name:	DSC02821.JPG	Altitude:	71.95m
Date taken:	Feb 11, 2016 1:59:11 PM	Heading:	Northeast (66.16°)
Position:

1050227

Severity: 5

Lightning strike

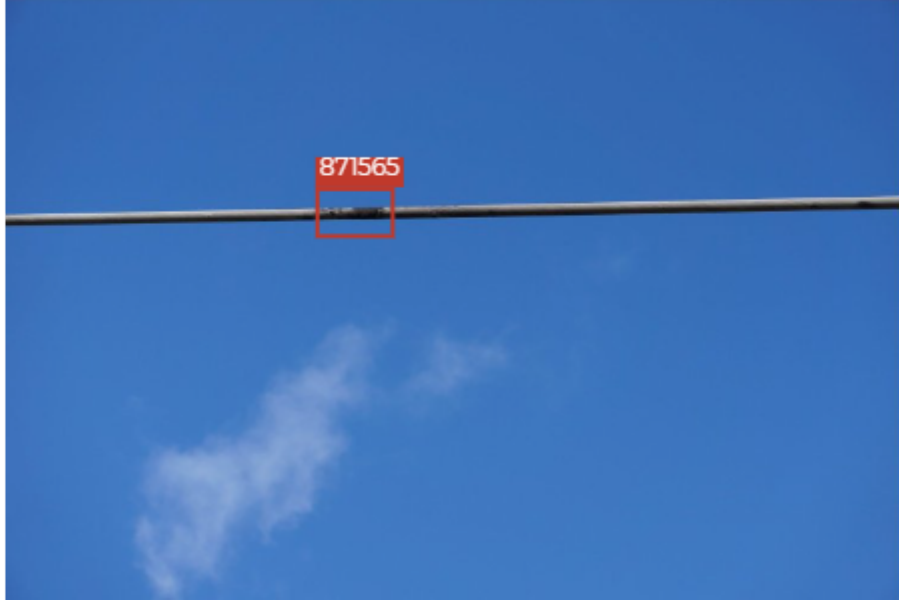
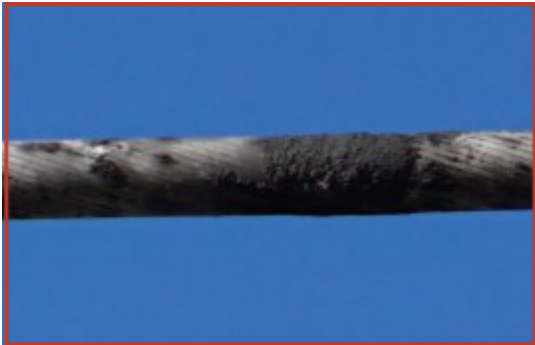
File name:	DSC4113.JPG	Altitude:	21.71m
Date taken:	Feb 25, 2016 3:10:58 PM	Heading:	North (343.2°)
Position:

871565 Severity: 5 Lightning strike
