## Roof Inspection - Lollandsgade (dummy)

Report date:  
**Aug 5, 2020**

Type:  
**Roof**

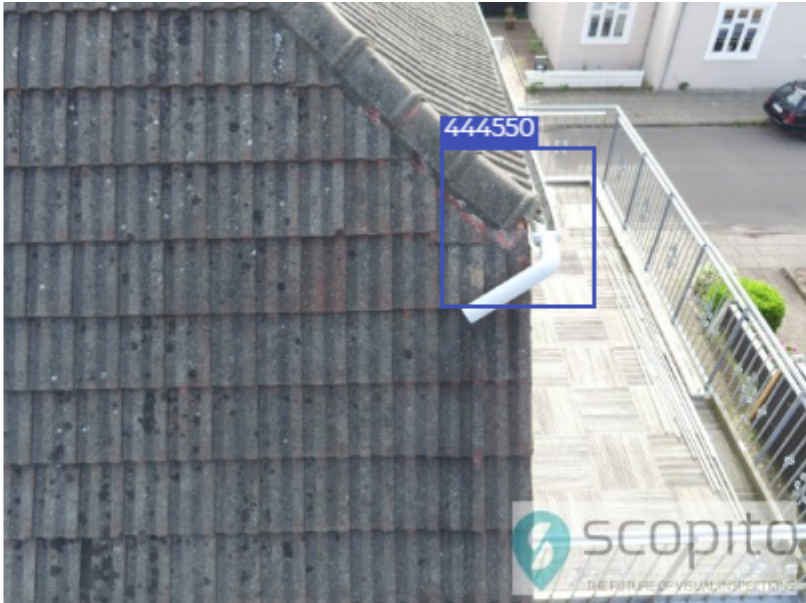
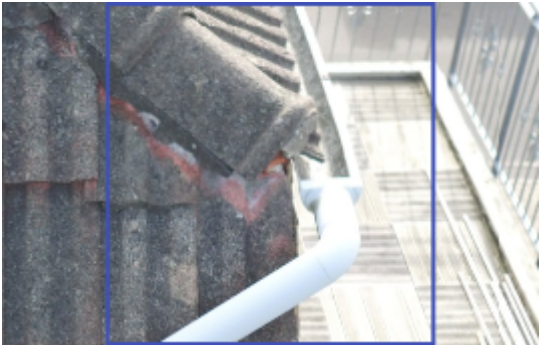
| Id | Severity | Issues | Comments | Page |
|---|---|---|---|---|
| 444550 | ? | Loose tile | Ridge lifting and slipped slate | 2 |

444550 Point of interest Loose tile

**Luke Delbarre:**  
Ridge lifting and slipped slate

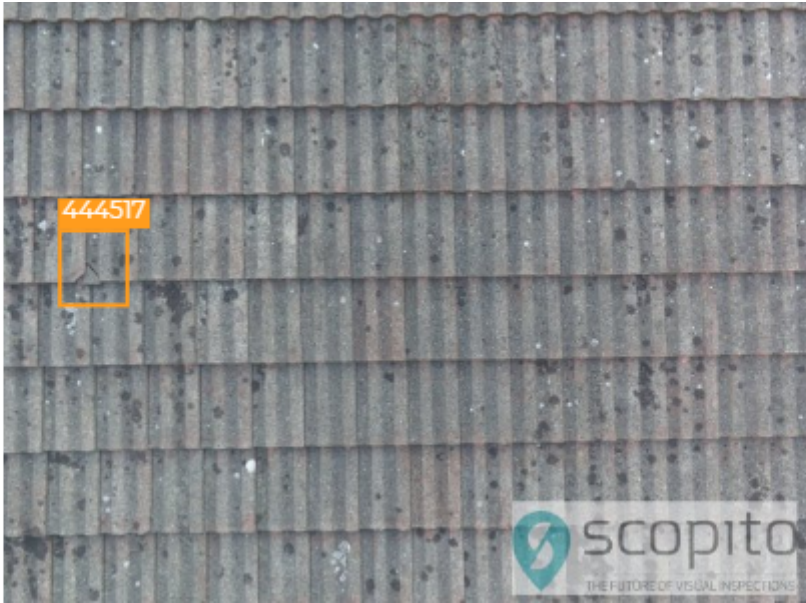
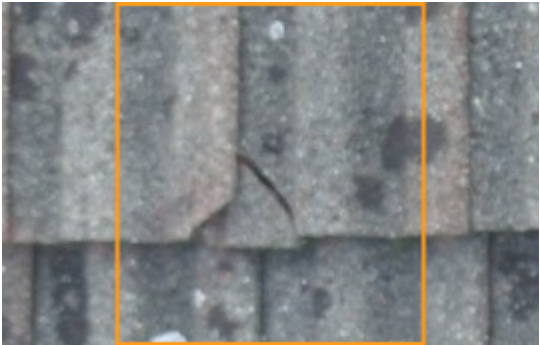
444517 Severity: 1 Broken Slate

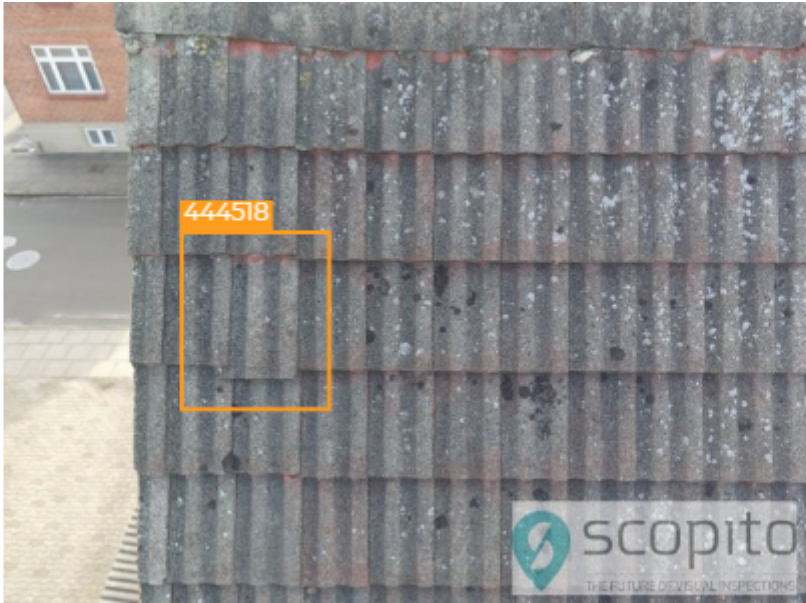
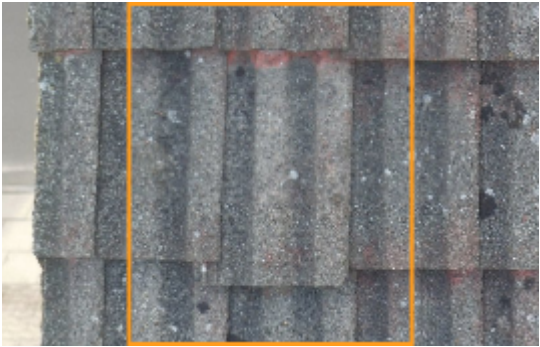
444518 Severity: 1 Loose tile

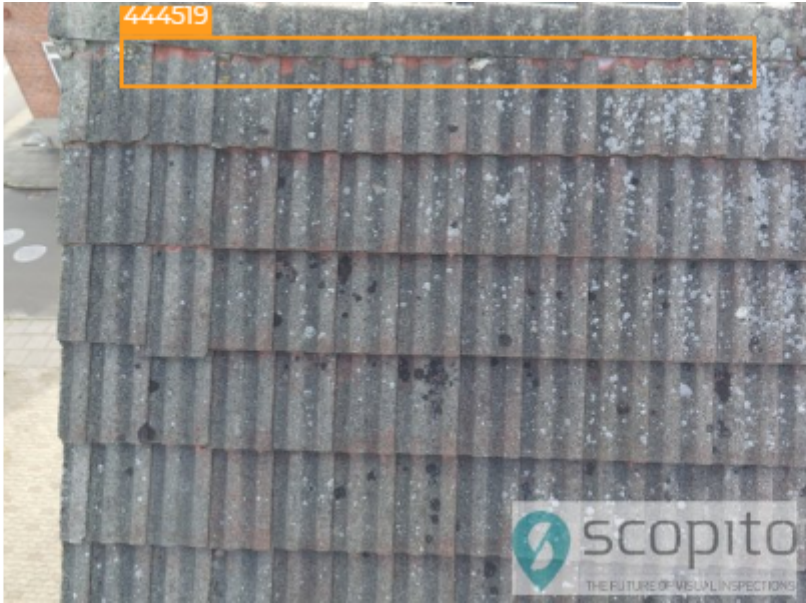
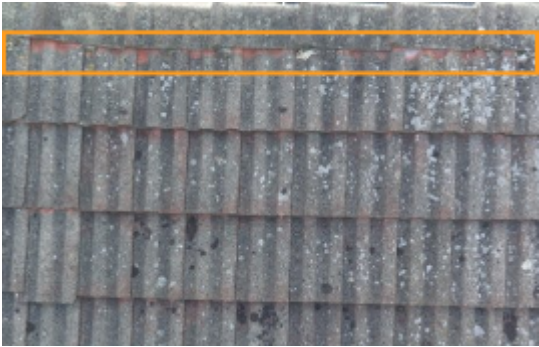
444519   Severity: 1   Loose tile

**Luke Delbarre:**  
possible slipping tiles

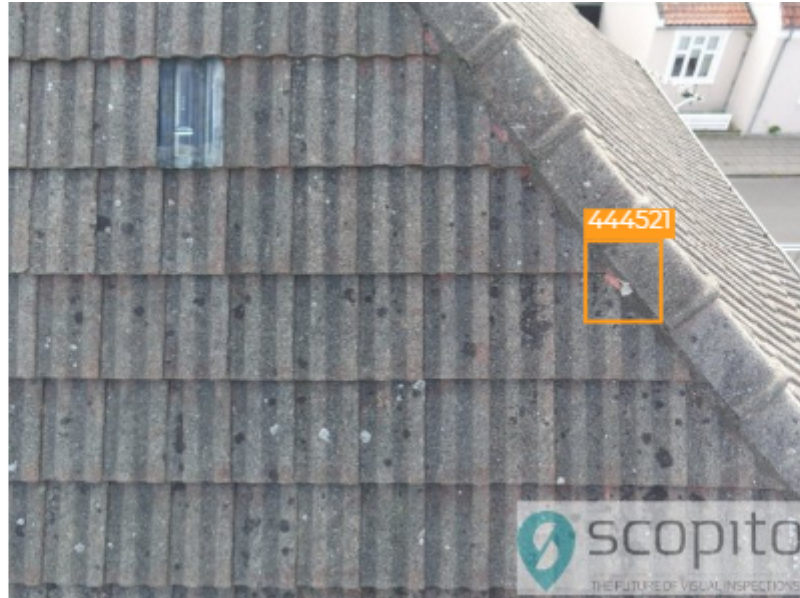
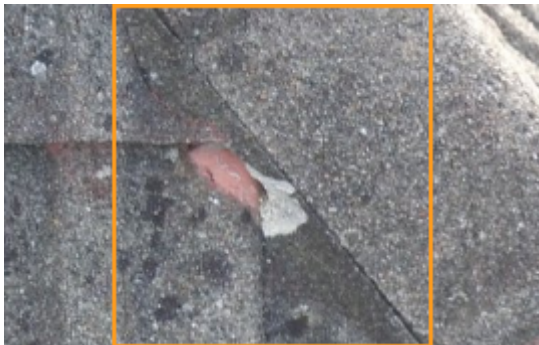
444521 Severity: 1 Broken Slate

Slate chipped needs some mortar

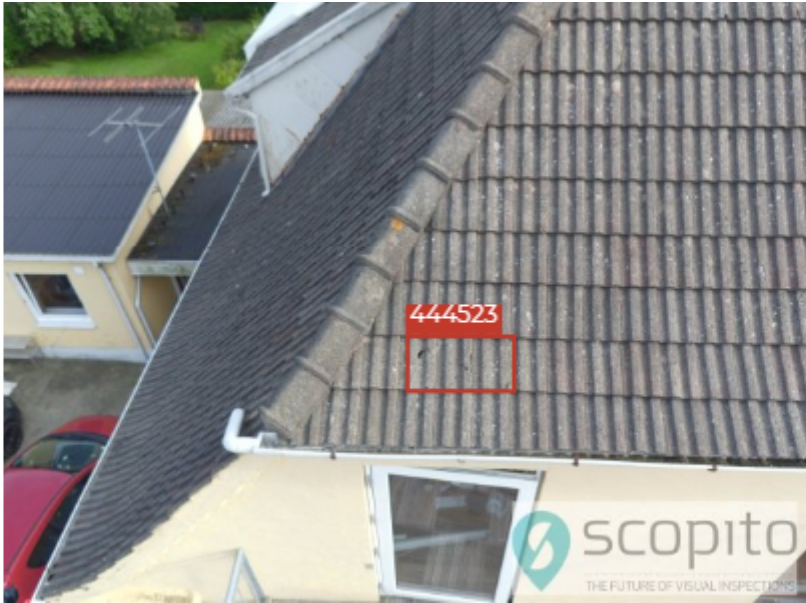
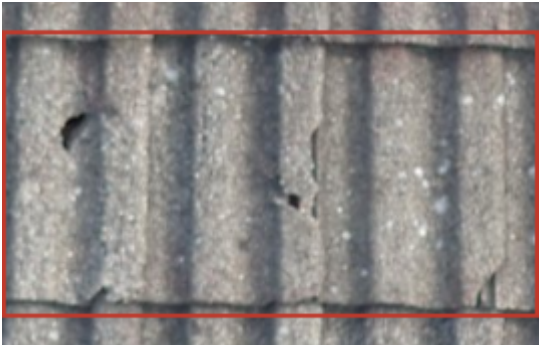
444523 Severity: 5 Broken Slate

**Luke Delbarre:**  
Hole in tile

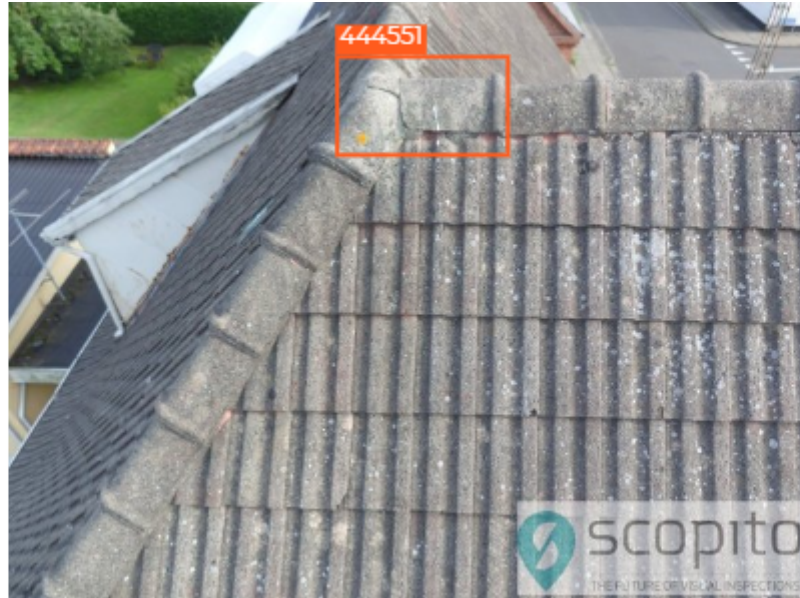
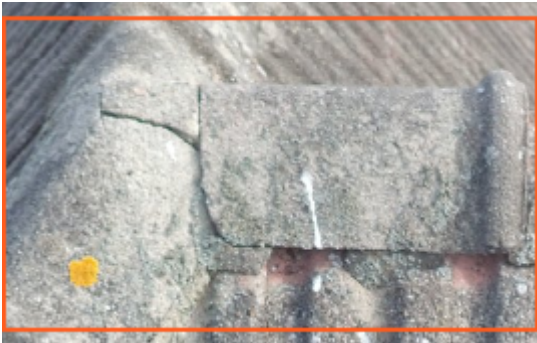
444551 Severity: 3 Loose tile

**Luke Delbarre:**  
Ridge tile needs re-pointing

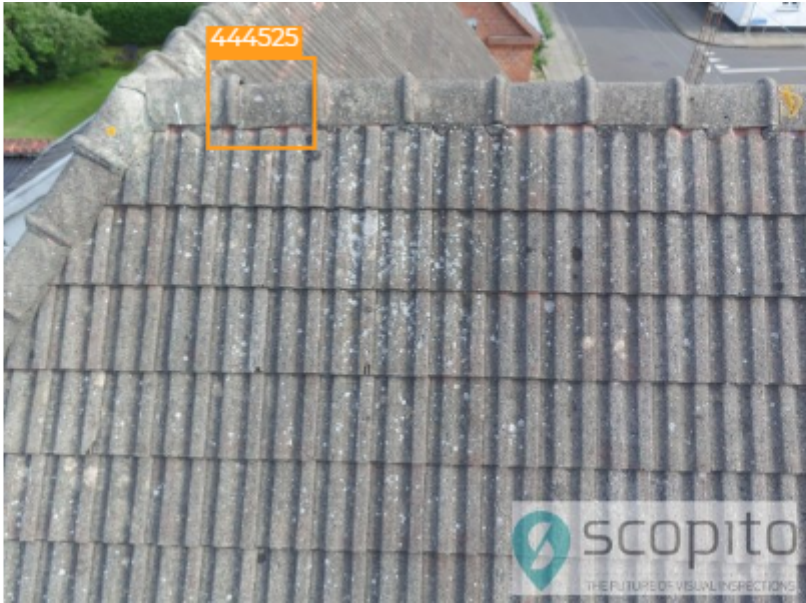
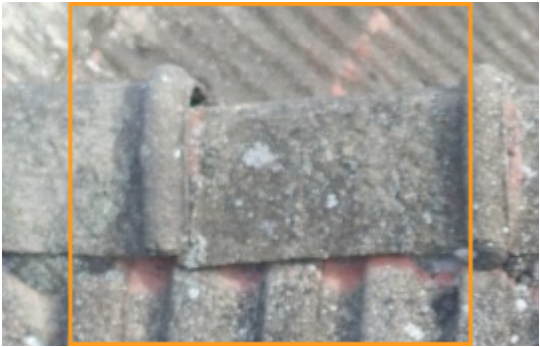
444525 Severity: 1 Loose tile

**Luke Delbarre:**  
loose ridge tile

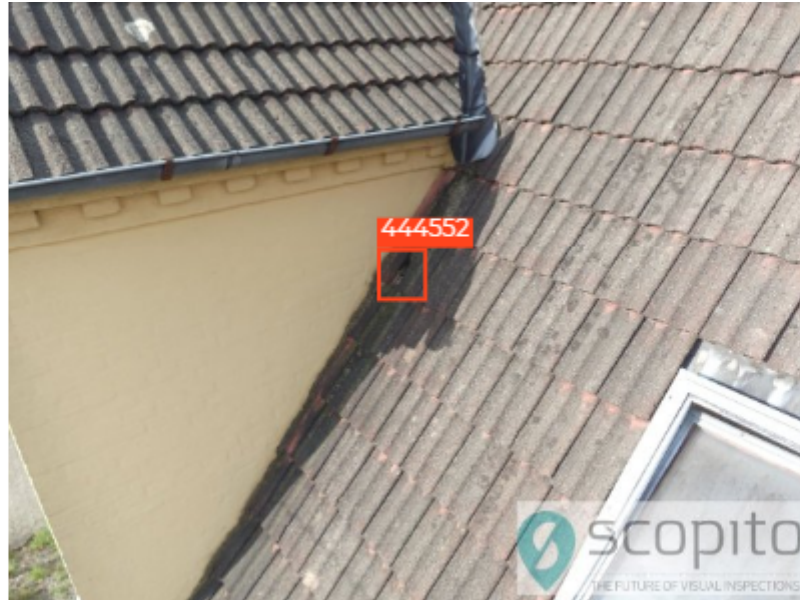
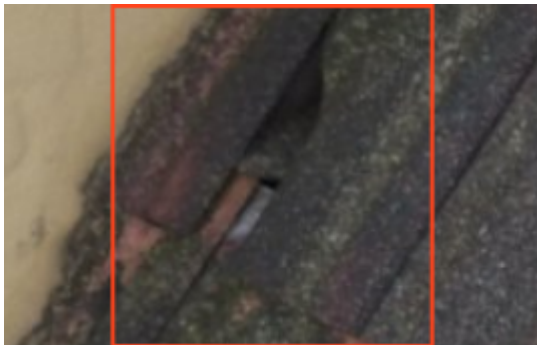
444552 Severity: 4 Broken Slate

**Luke Delbarre:**  
hole in roof

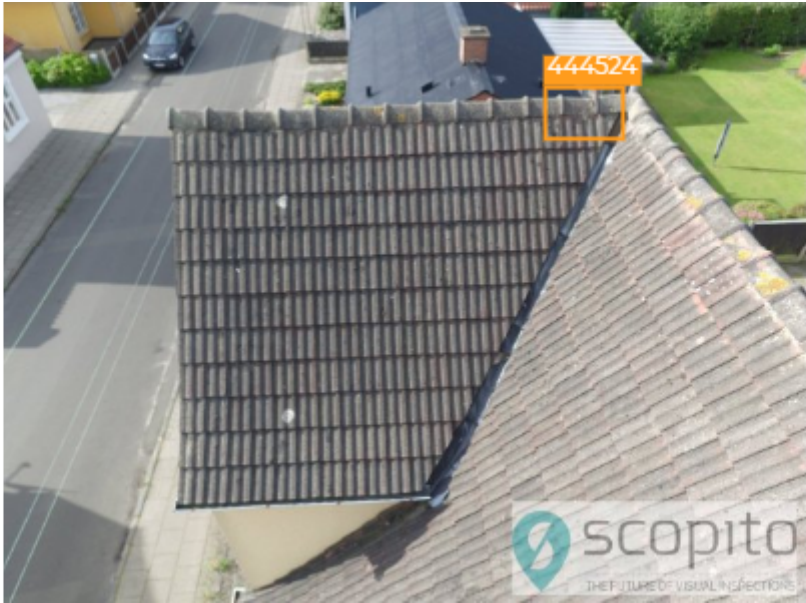
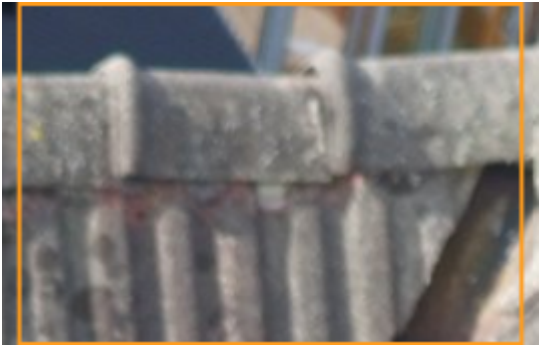
444524 Severity: 1 Small issue

**Luke Delbarre:**  
loose ridge tile
