Bellmere (Site No. 4510003)

Report date:
Aug 24, 2020

Type:
Cell Tower

F03 Preliminary Report for Site No. 4510003

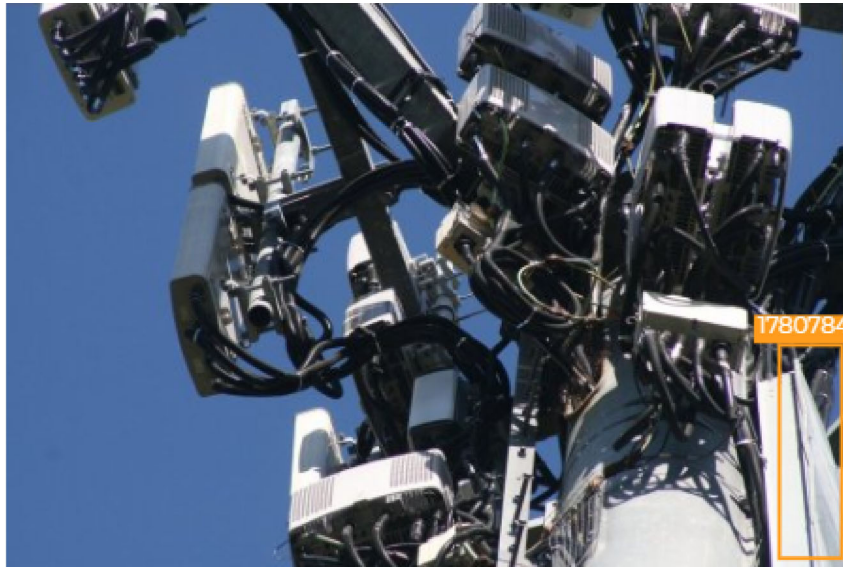
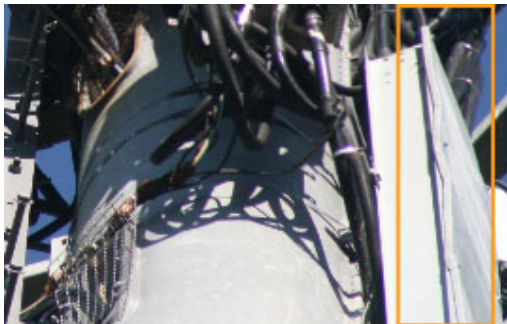
1780784 Severity: 1 Damage

Minor damage to cable tray cover.

Use caution when removing cable tray cover to prevent bending and further damage.

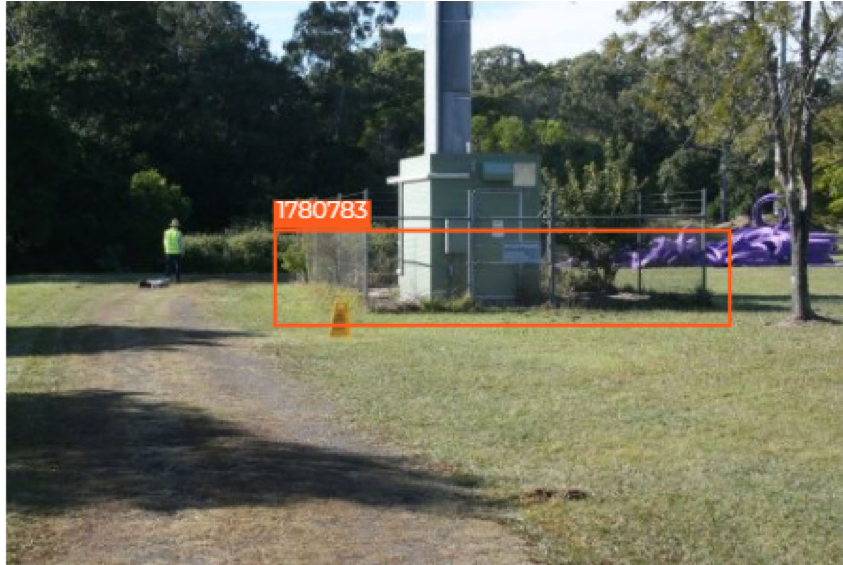
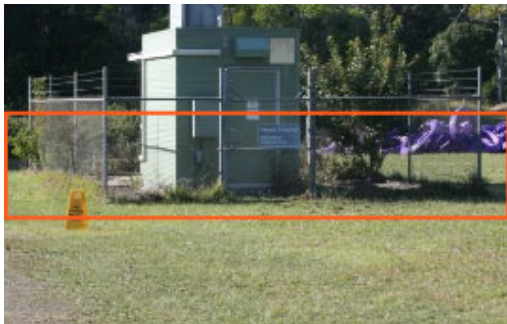
1780783 Severity: 3 Vegetation

Moderate vegetation growth around base of tower.

The security perimeter and safety signage all appear to be in good condition. It is recommended that the site location and contact information sign be reviewed and updated if necessary. It is also recommended to clean vegetation inside fence perimeter on next site visit.

Remove vegetation from inside fence perimeter and minimum 1.5 meters around the outside of fence perimeter.

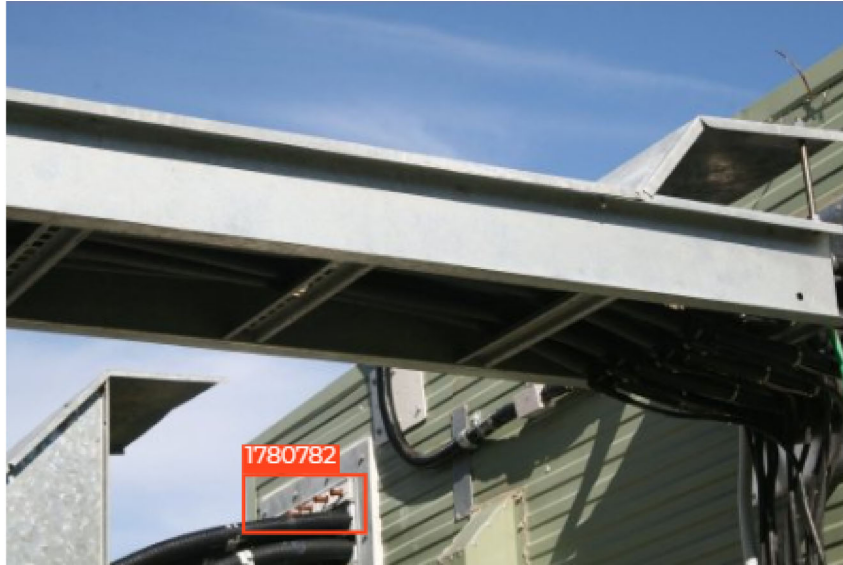
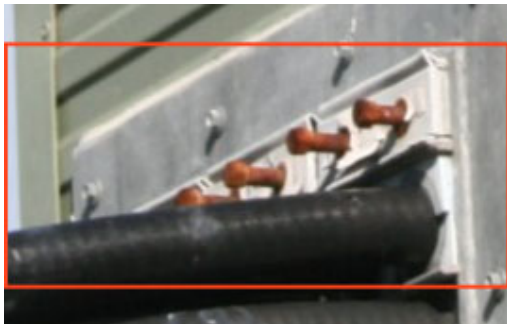
1780782 Severity: 4 Corrosion

Hardware corrosion. Metal loss starting to occur.

Replace hardware in 3-6 months.

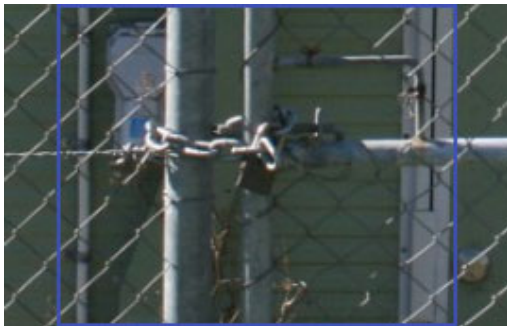
1780778 Point of interest Safety & Security

Brian O'Hanlon:
Lock secure.

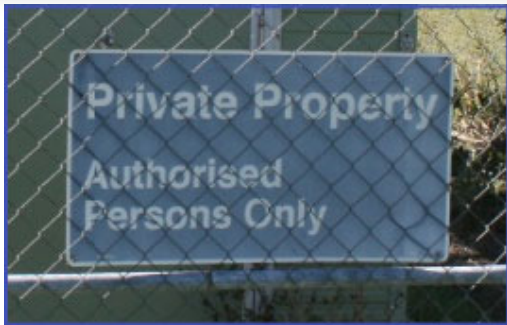
1780779 Point of interest Safety & Security

Brian O'Hanlon:
Signage in place.

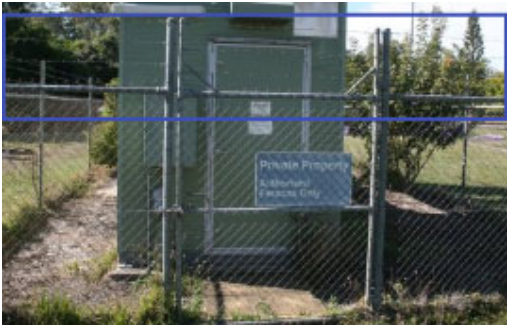
1780780 Point of interest Safety & Security

Fence and razor wire in good condition.

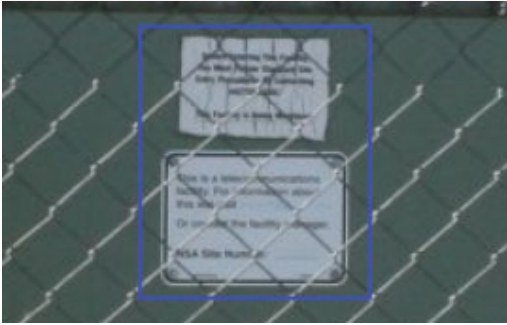
1780781 Point of interest Security

Verify contact information is up to date. Site number appears to be faded.

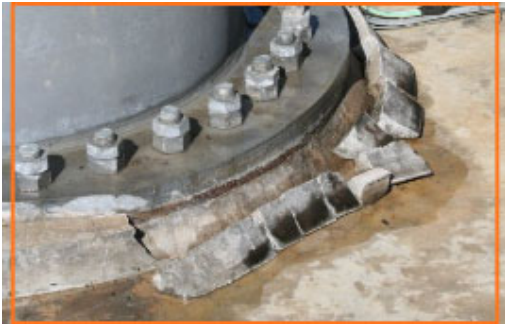
1780775 Severity: 2 Damage

The concrete apron around the base of the tower is damaged. This exposed advancing corrosion around the bottom of the base plate. Recommended that an accredited inspector determine severity of corrosion.

Damage to concrete apron around base of tower.

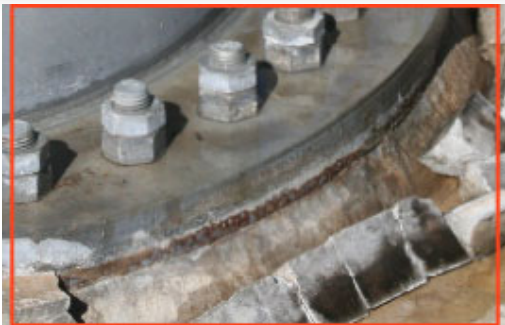
1780776 Severity: 4 Corrosion

Corrosion around tower base flange. Likely a result of the concrete apron trapping water between the concrete and steel.

Consider modifying the concrete apron to reduce the risk of long term corrosion damage. Consult with an engineer with specific corrosion expertise.

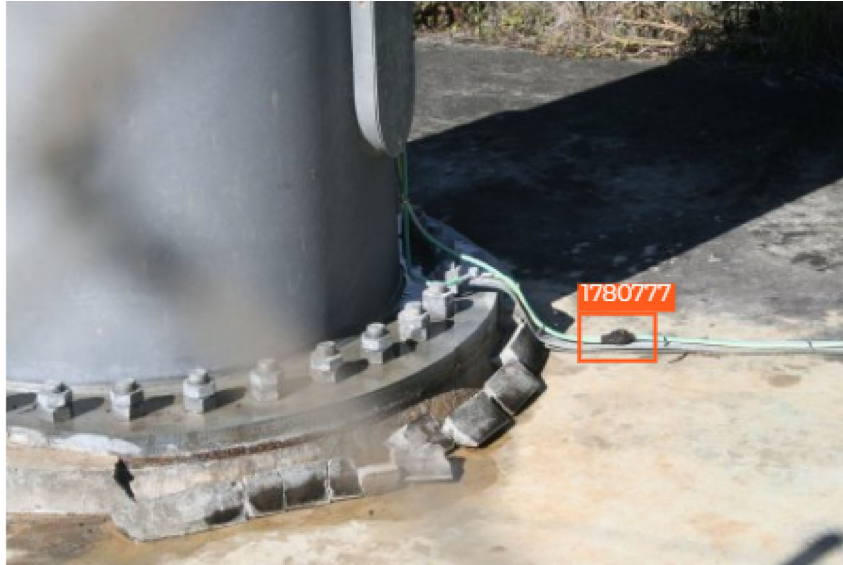
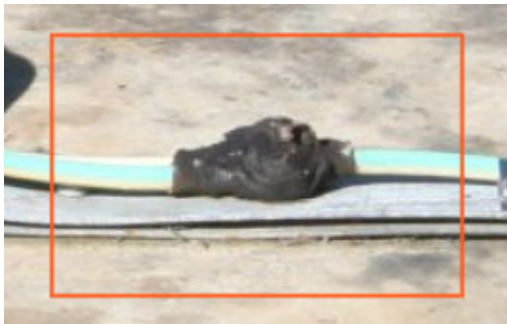
1780777 Severity: 3 Wiring

Ground wire connection cover looks worn and exposed.

Check condition of this ground wire connection and re-seal if necessary.

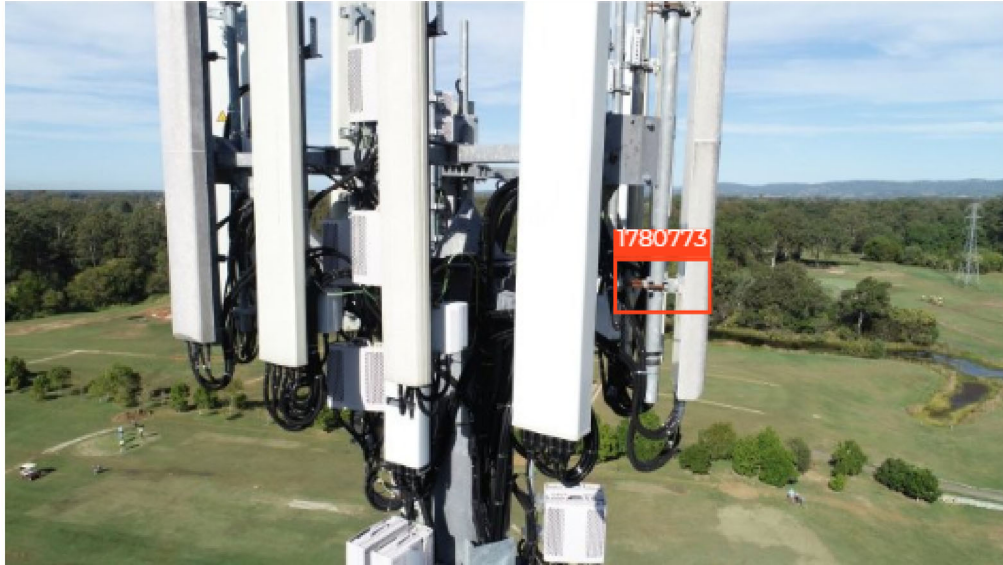
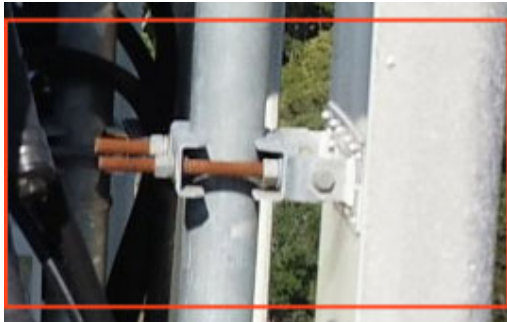
1780773 Severity: 4 Corrosion

There is visible surface rust and initial metal loss on the western facing antenna threaded rods and nut on northeast facing antenna. Recommended that an accredited inspector determine severity of corrosion. Suggest nuts and threaded rods be swapped out at next site visit.

Threaded rods corroded. Metal loss starting to occur.

Replace 2 threaded rods in 3-6 months.

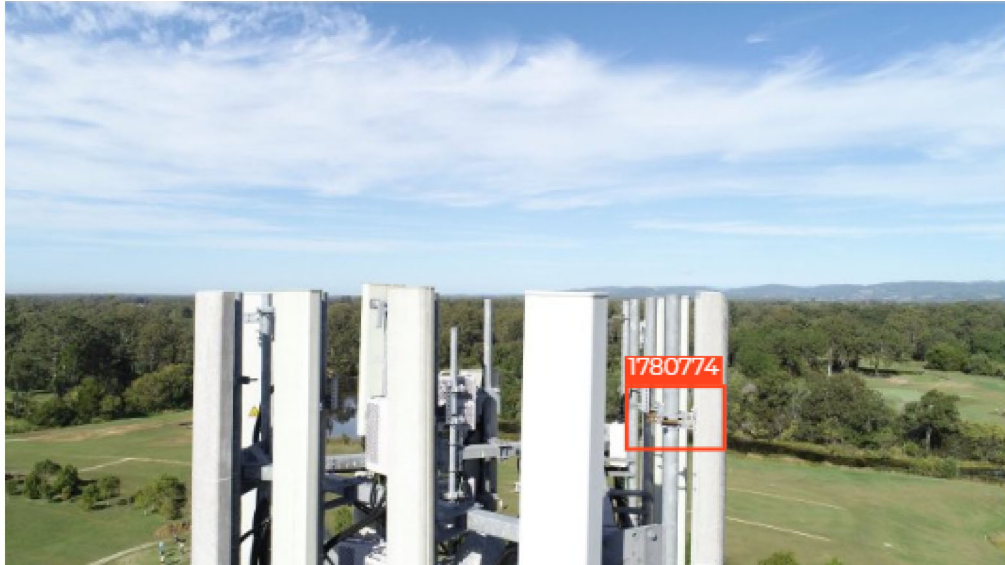
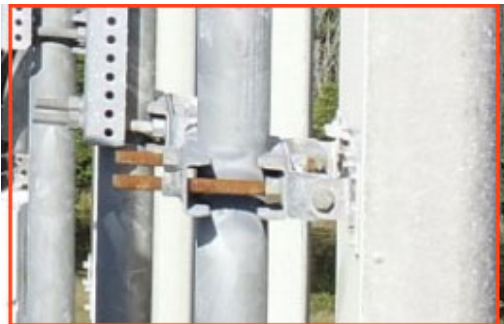
1780774 Severity: 4 Corrosion

Threaded rods corroding. Metal loss staring to occur.

Replace 2 threaded rods in 3-6 months.

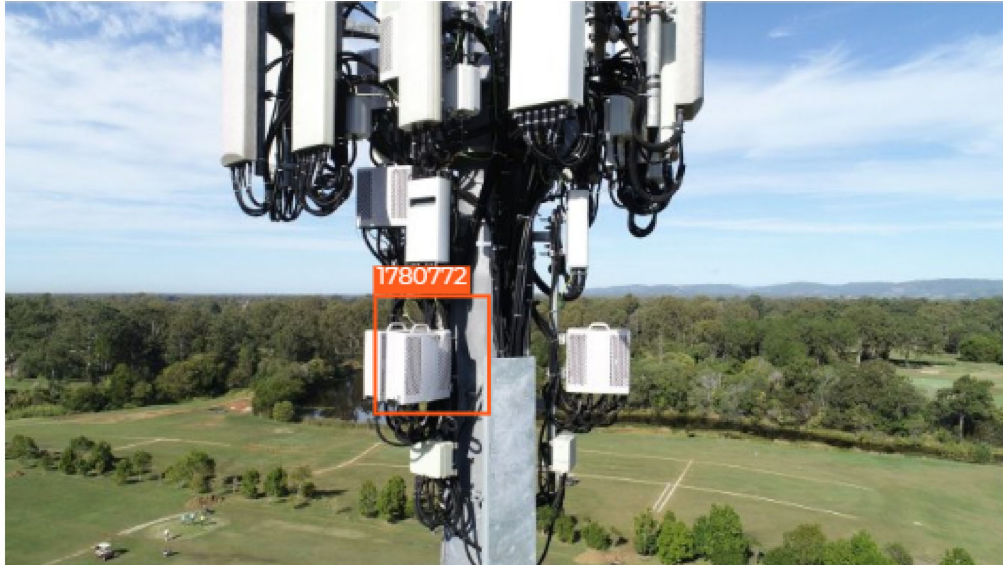
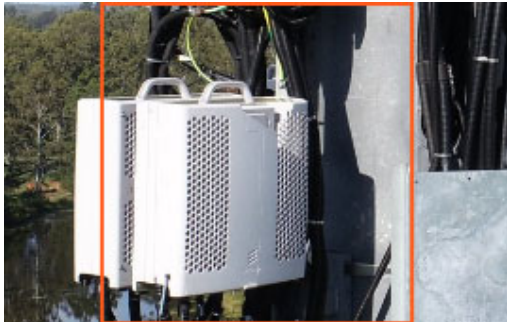
1780772 Severity: 3 Damage

The damaged RRU on the northern face appears to be cosmetic only. The integrity of the RRU should be checked on next site visit.

Damaged RRU cover

Check RRU on next tower climb to insure damage does not impact weather integrity or any critical components.

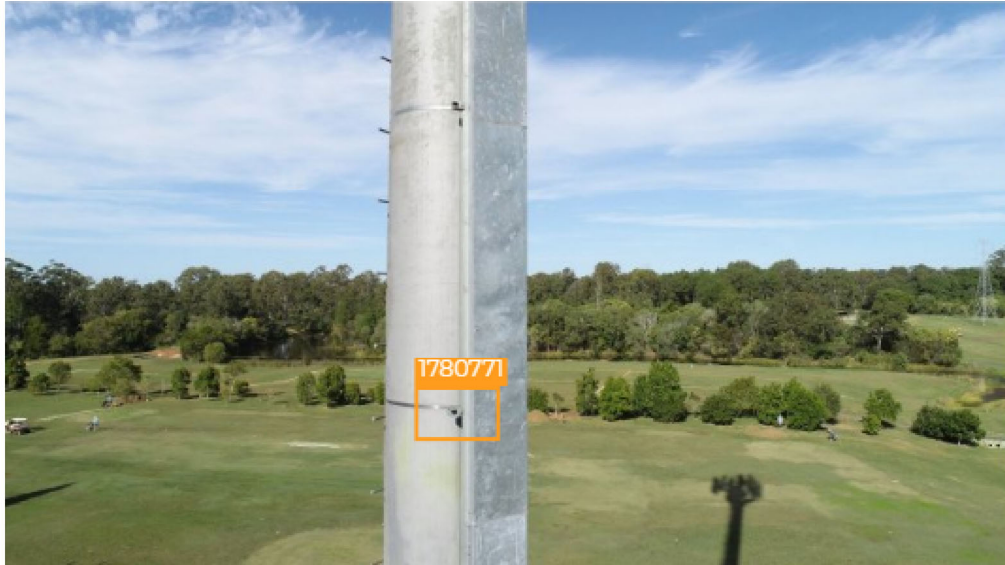
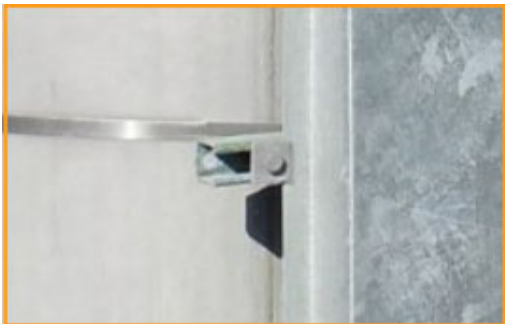
1780771 Severity: 1 Corrosion

Initial signs of oxidation on bracket support.

Inspect bracket on next tower climb.

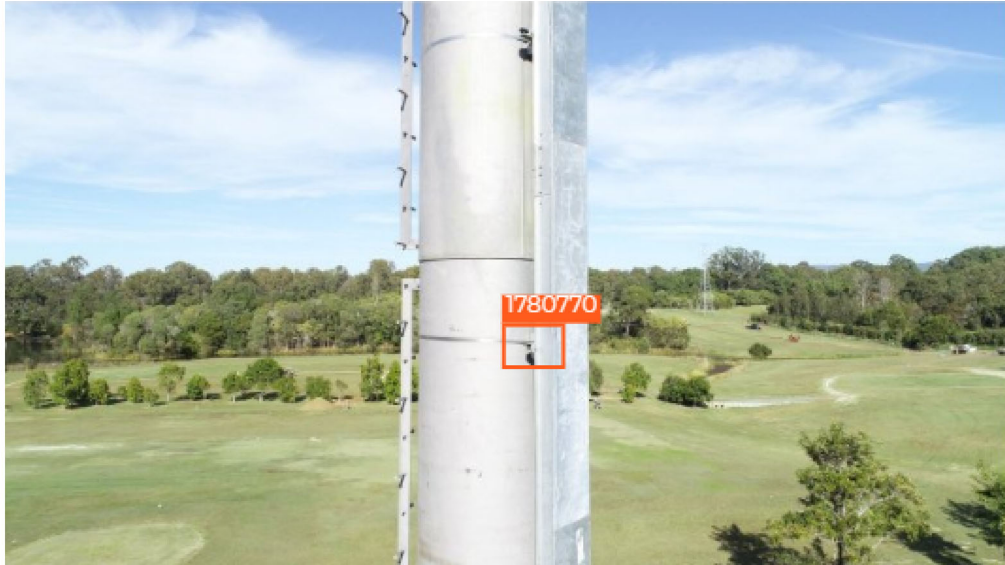
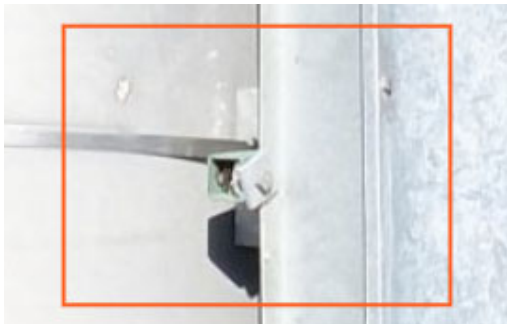
1780770 Severity: 3 Safety & Security

Unknown object inside bracket. Possible wildlife, climbers should take care on next climb.

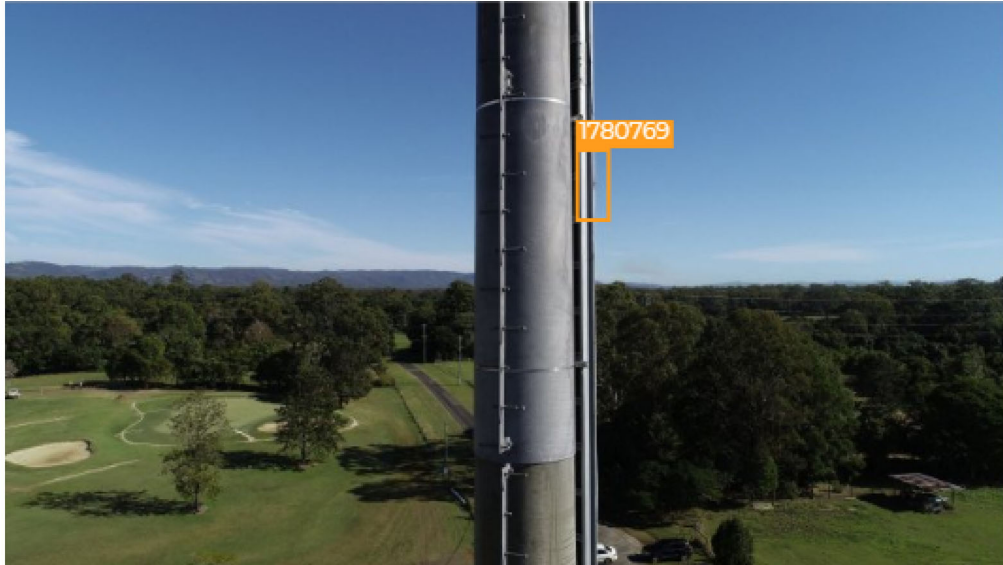
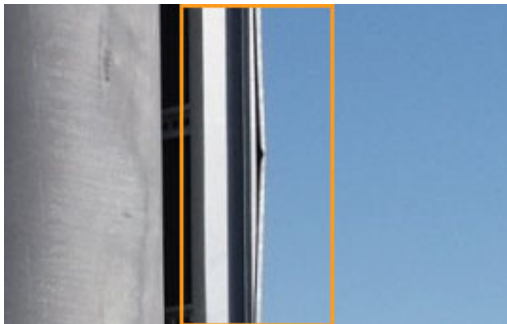
1780769 Severity: 1 Damage

Minor damage to cable tray cover.

Use caution to prevent the cover from bending and creating a weak seam when removed.

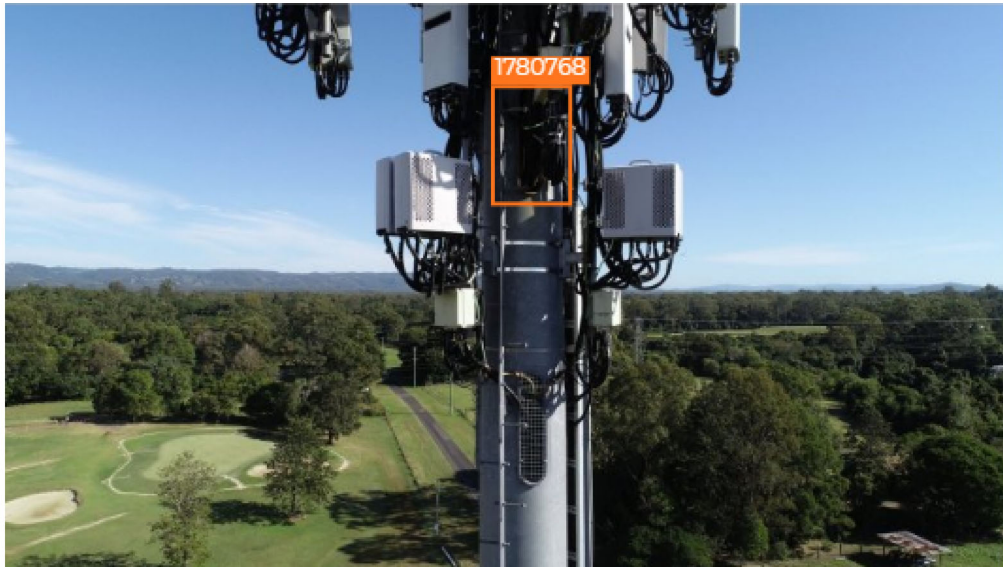
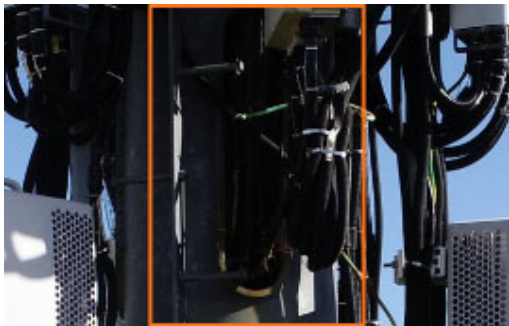
1780768 Severity: 2 Safety & Security

Screen damaged.

Replace screen to prevent birds and wildlife from entering tower structure.

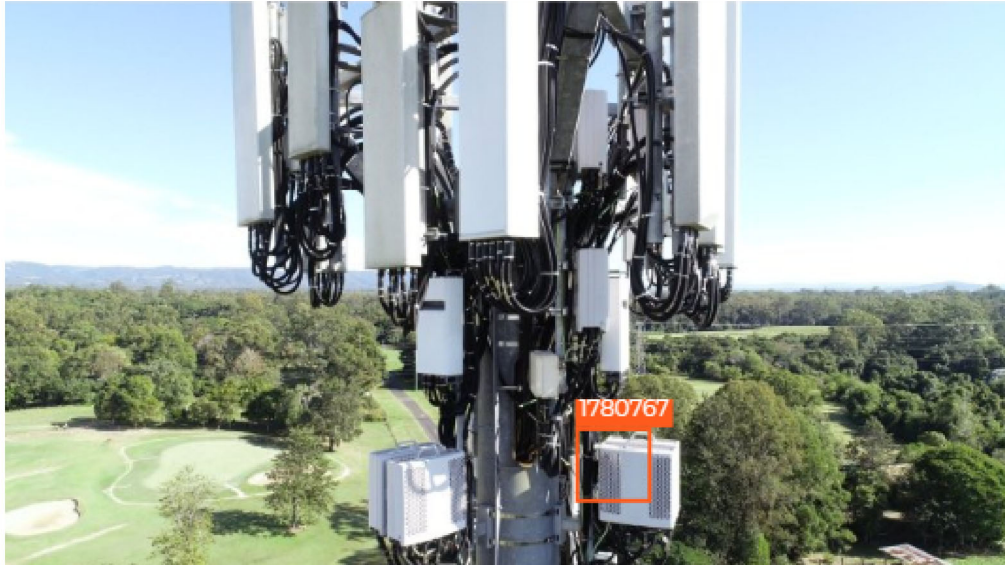
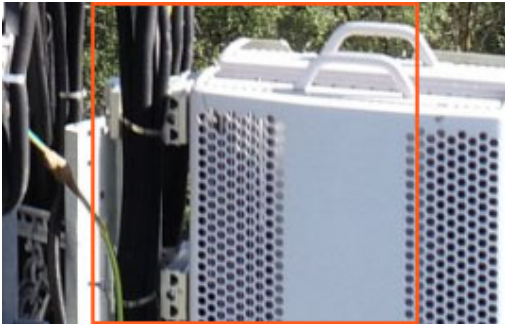
1780767 Severity: 3 Damage

Damage to exterior of RRU.

Check RRU for damage to seals or internal components.

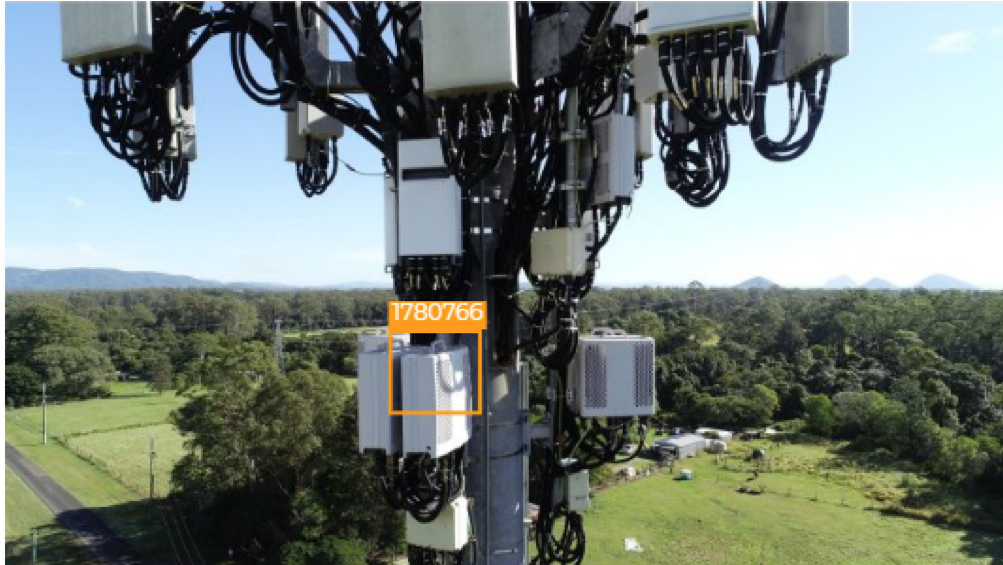
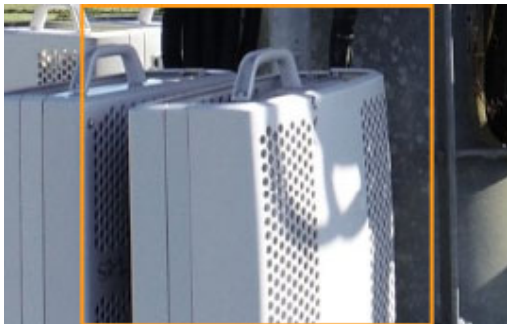
1780766 Severity: 1 Area of Interest

RRU cover out of alignment.

Check attachment of RRU cover and re-align if necessary.

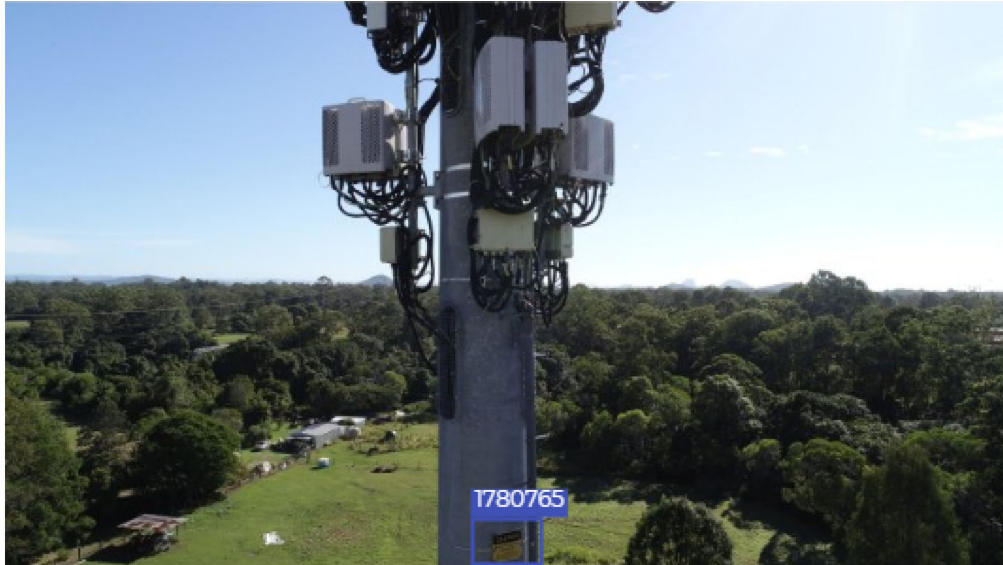
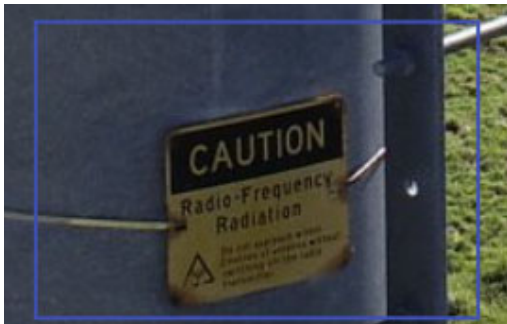
1780765 Point of interest Safety & Security

Brian O'Hanlon:
Safety signs in place.

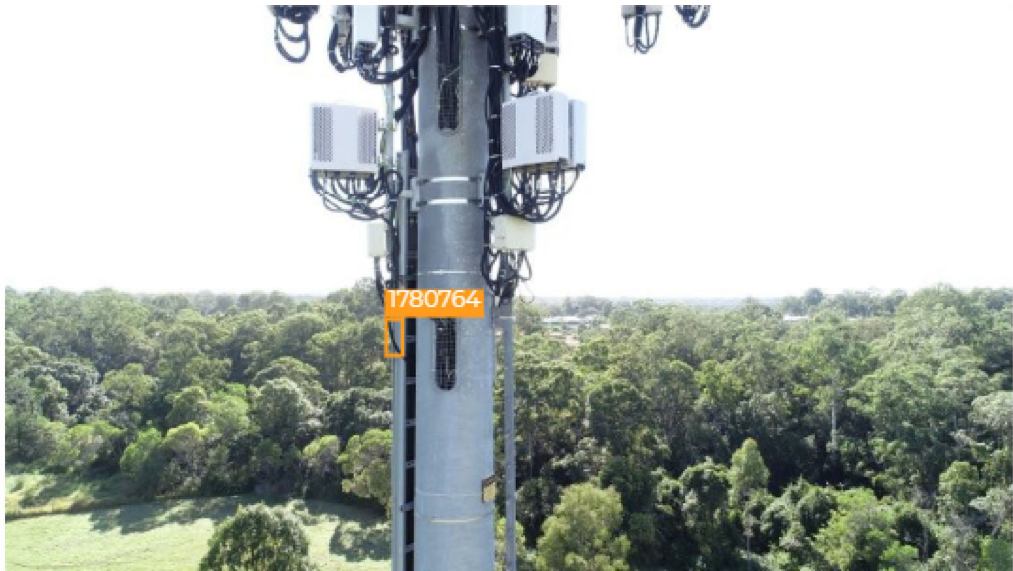
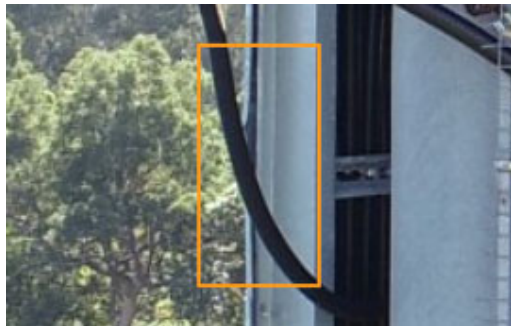
1780764 Severity: 1 Damage

Brian O'Hanlon:
Damage to cable tray cover. Cover may bend and create a seam when removed.

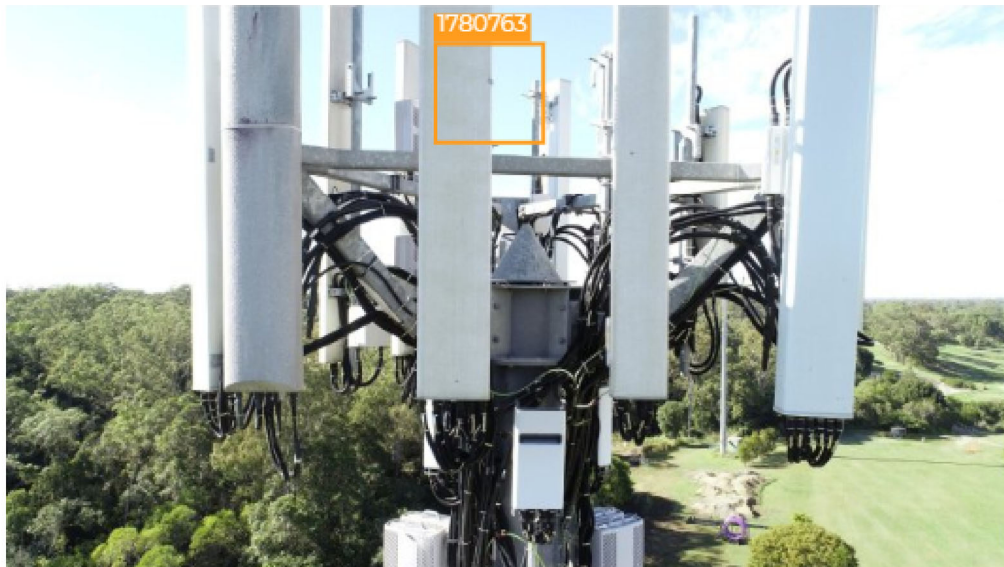
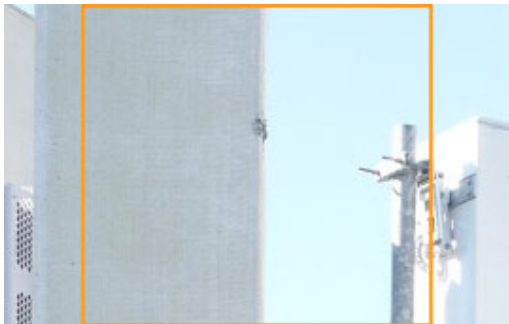
1780763 Severity: 1 Damage

Brian O'Hanlon:
Minor damage on RF cover.

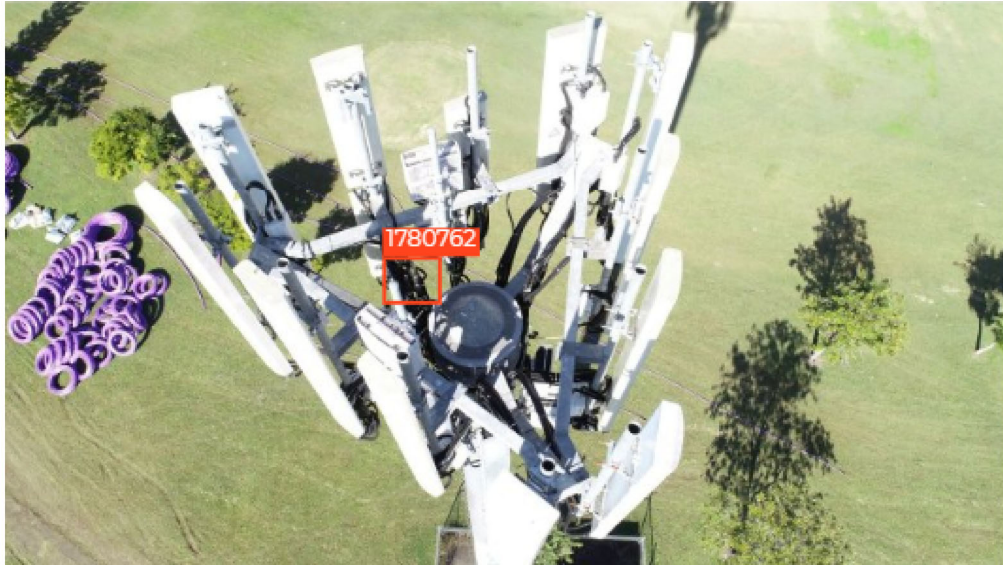
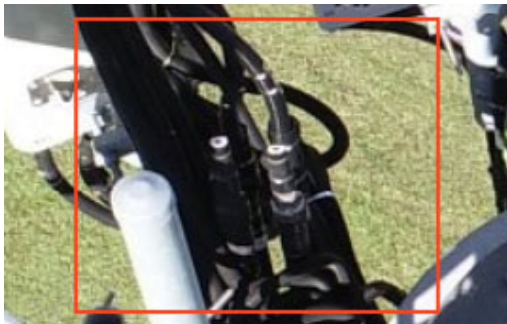
1780762 Severity: 4 Damage

The coax cable at the top of the monopole has not been sealed. Recommend this be brought to the attention of wireless network engineering and actioned as priority.

Cables cut with ends exposed.

Install proper protective termination to preserve cables for future use.

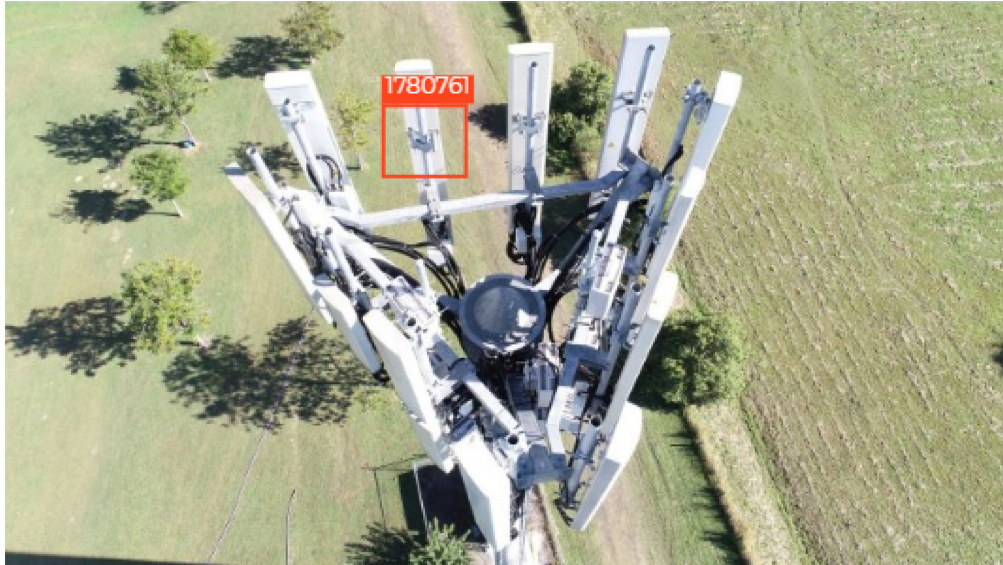
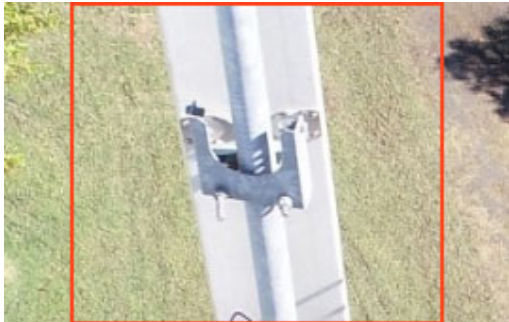
1780761 Severity: 4 Hardware

Antenna bracket on western facing antenna night aligned to antenna. Suggest adjusting and re-securing this bracket at next site visit.

Clamp is not aligned square to antenna.

Check clamp alignment and re-adjust if necessary.

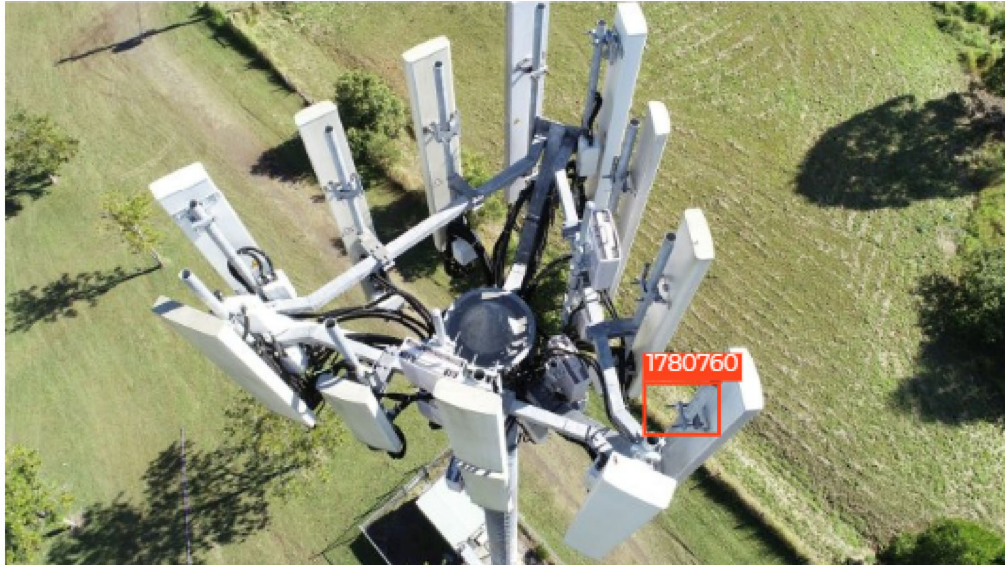
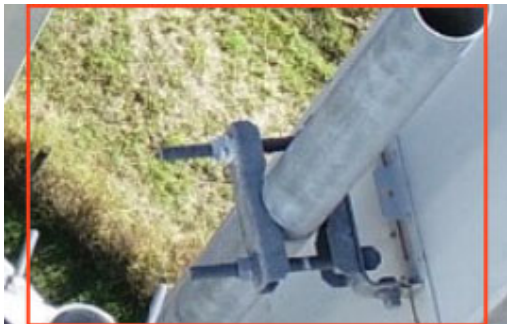
1780760 Severity: 4 Corrosion

Nut is corroding. Metal loss . No security nut in place.

Replace nut in <3 months.

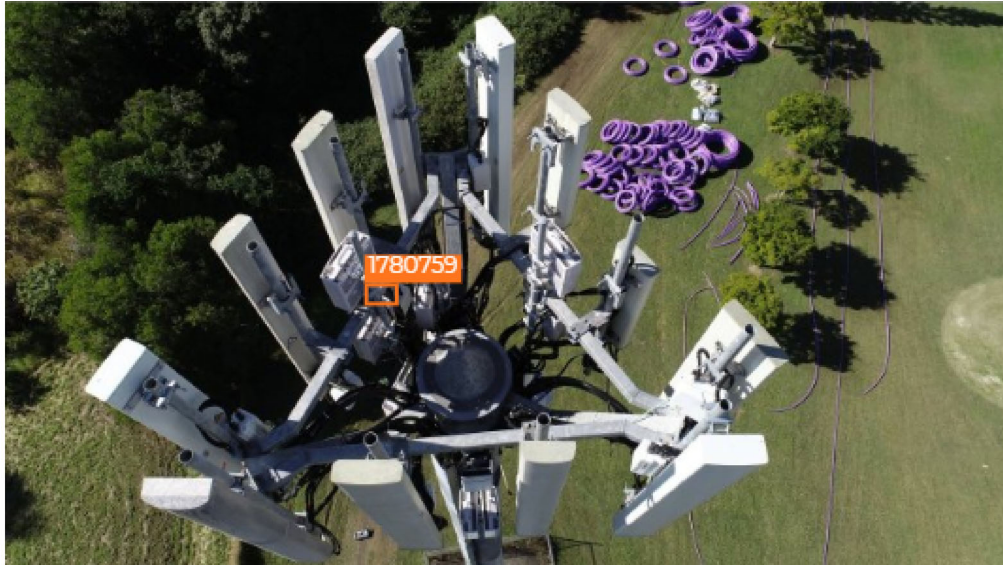
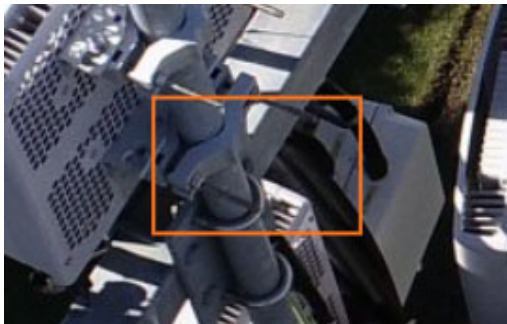
1780759 Severity: 2 Corrosion

Brian O'Hanlon:
Light oxidation on threaded rods.

Remedy action:
Monitor durring future inspections.
