# Distribution demo - Lineman analysis

Report date:	Type:	Company:	Report images:	Annotations:
Dec 2, 2020	Power Line	Scopito Demo 1	10	10

## Distribution demo - Lineman analysis - Summary

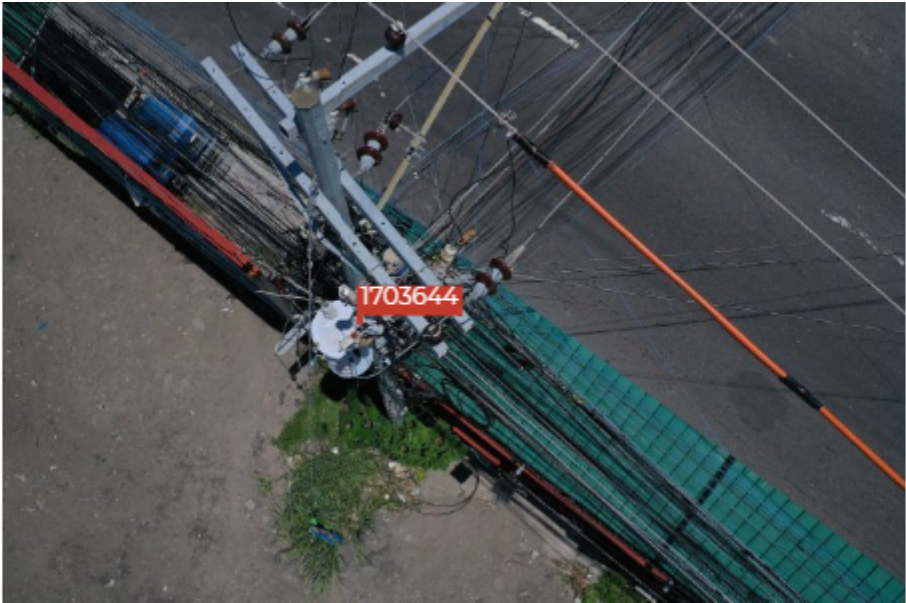
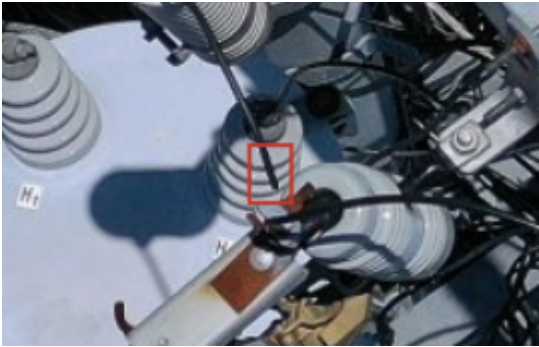
1703644    Severity: 5    Conductor Damage

**Phil Lewis:**  
burned arrestor lead

**Remedy action:**  
repair/replace

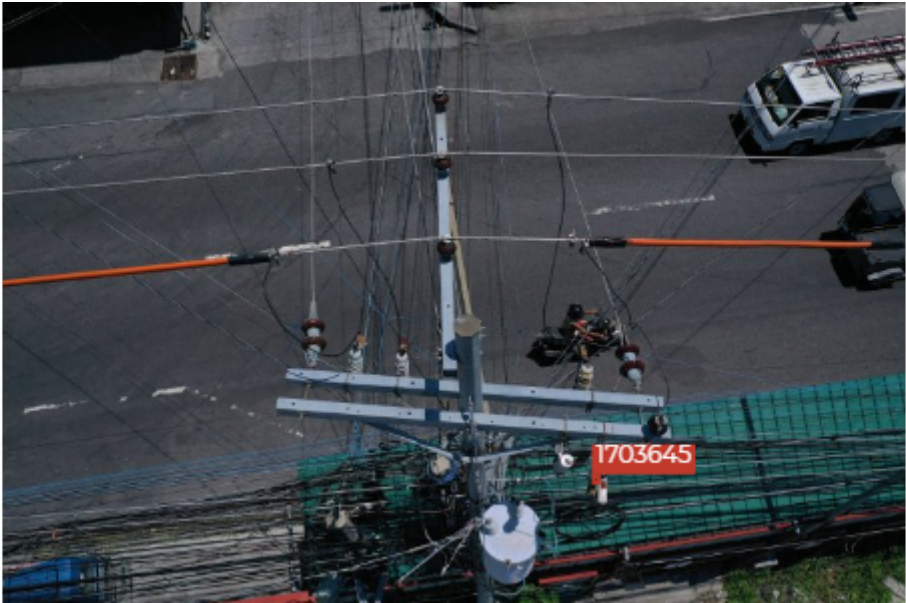
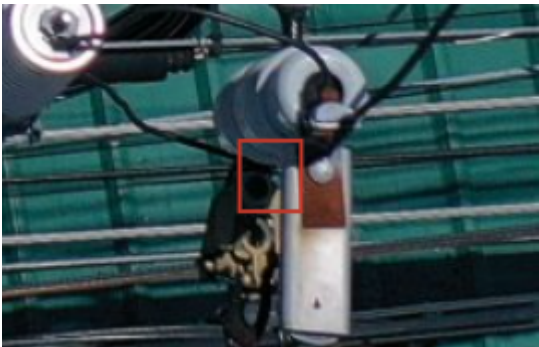
1703645    Severity: 5    Conductor Damage

**Phil Lewis:**  
burned arrestor lead

**Remedy action:**  
repair

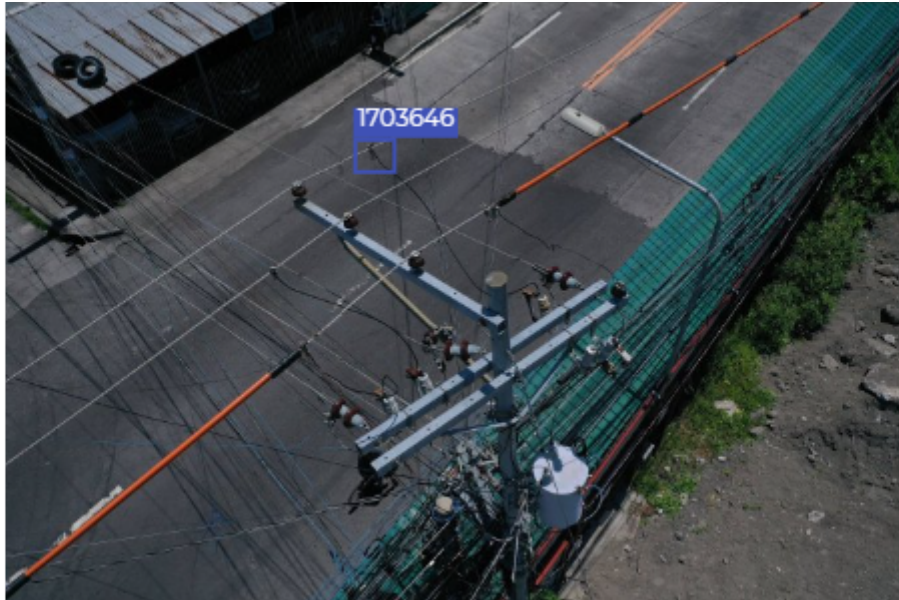
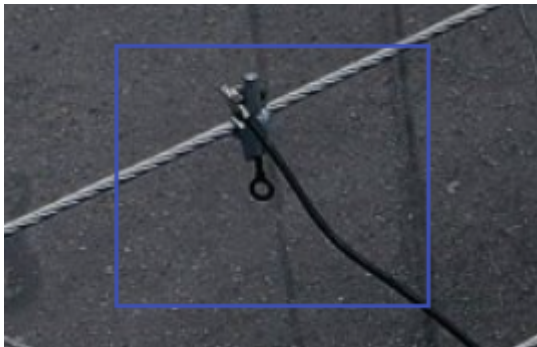
1703646

Past practice has shown that installing hot line clamps directly on the mainline conductor creates a significant risk of conductor burn down due to loose connection. Suggest using hot line stirrups.

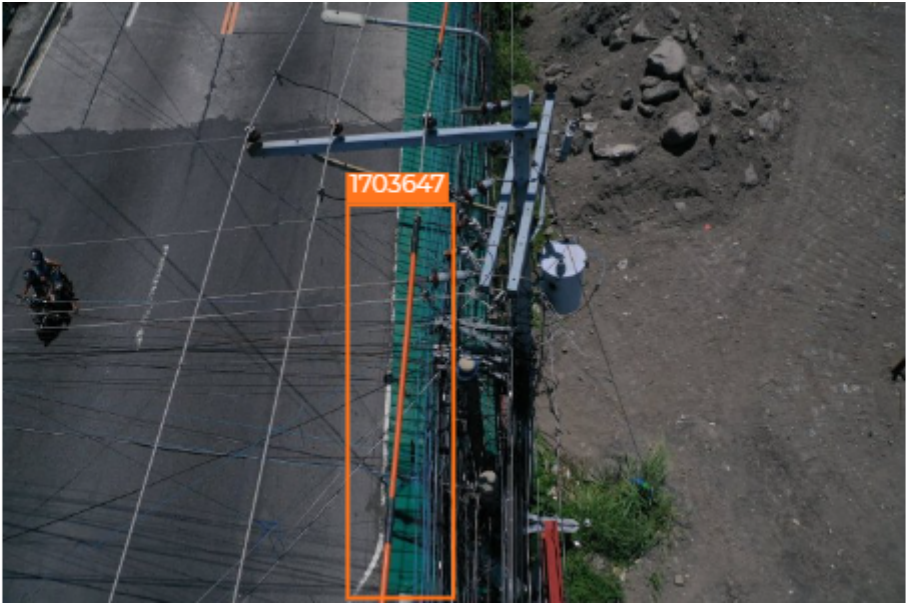
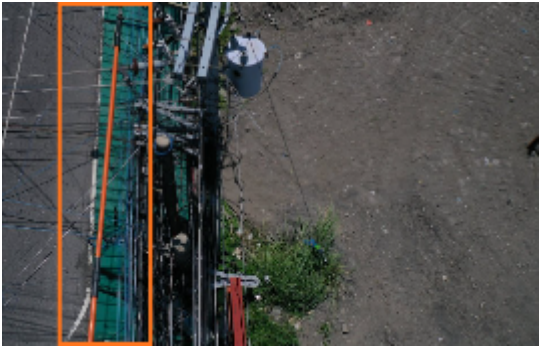
1703647    Severity: 2    Potential Hazard

**Phil Lewis:**  
Clearance issues?

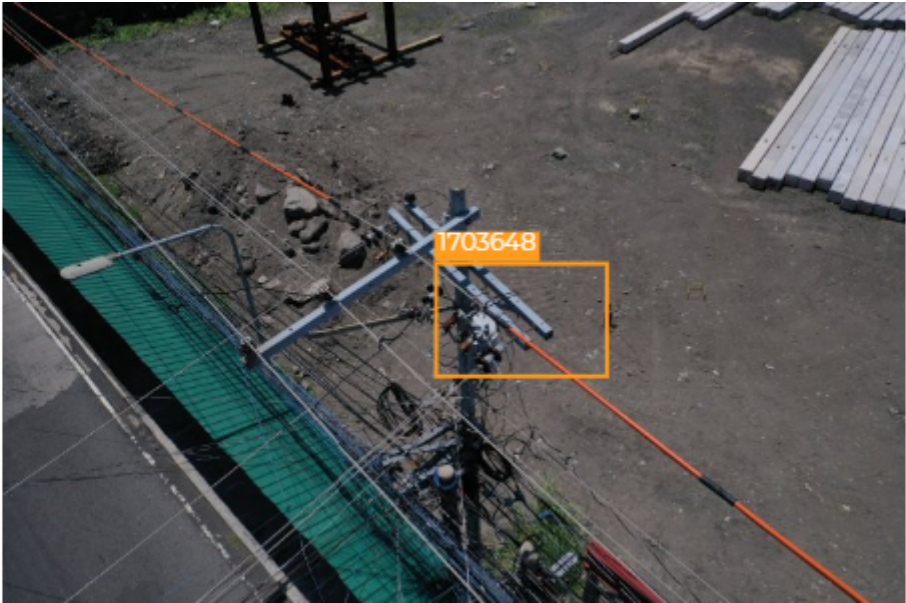
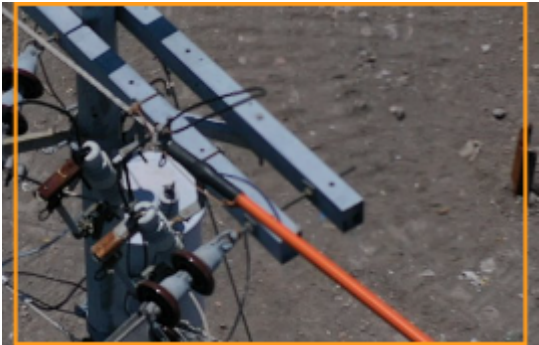
1703648    Severity: 1    Potential Hazard

**Phil Lewis:**  
clearance issues

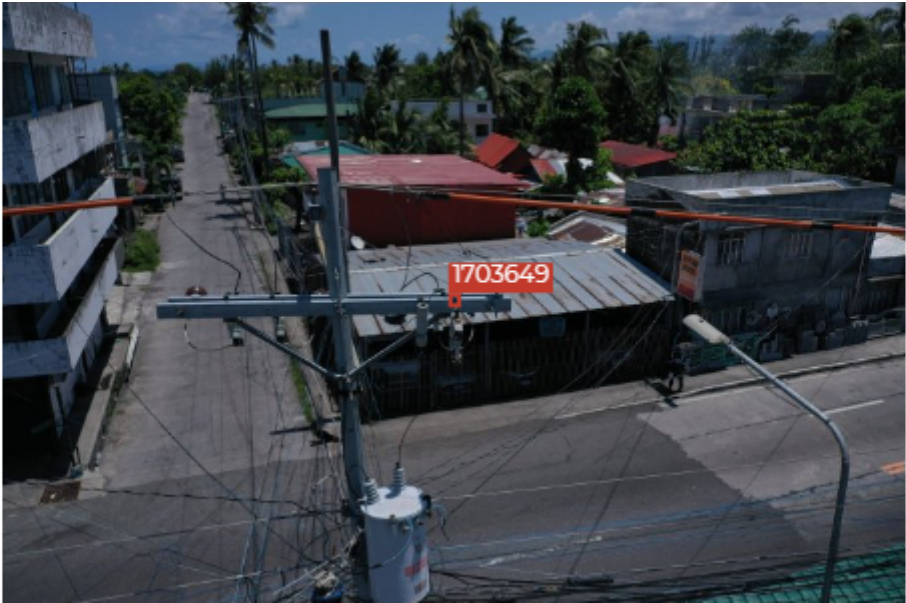
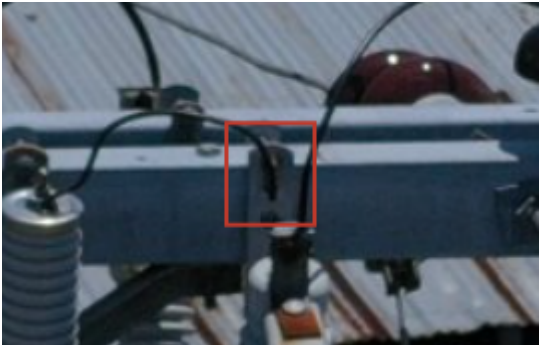
1703649    Severity: 5    Conductor Damage

**Phil Lewis:**  
burnt arrestor lead

**Remedy action:**  
repair

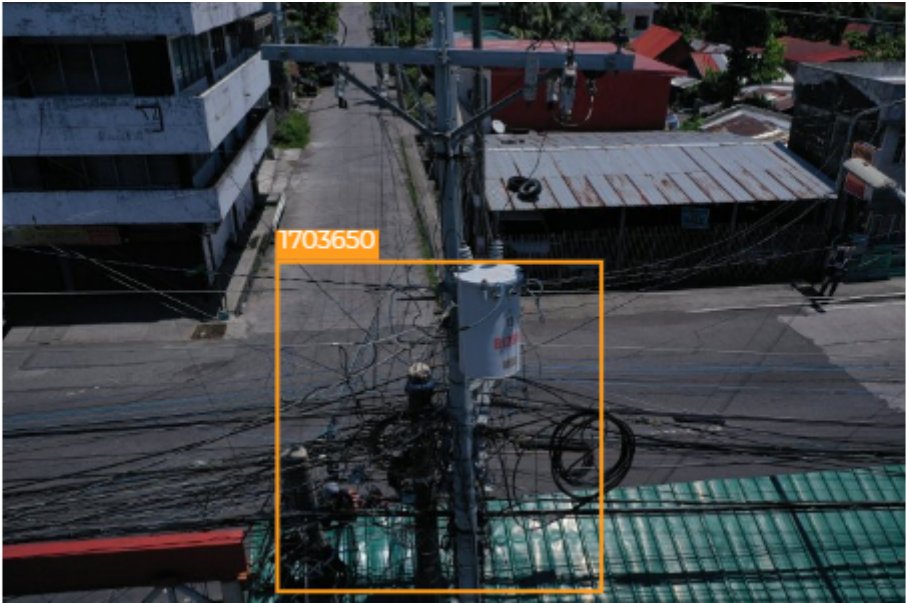
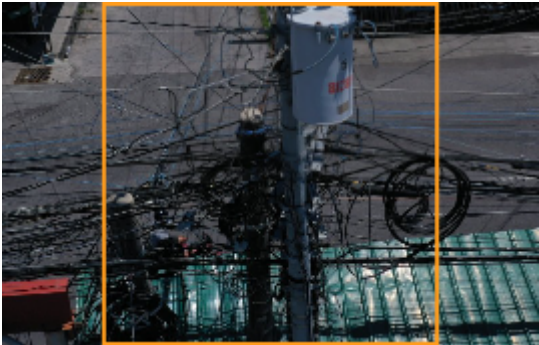
1703650    Severity: 1    Miscellaneous

**Phil Lewis:**  
severe pole congestion

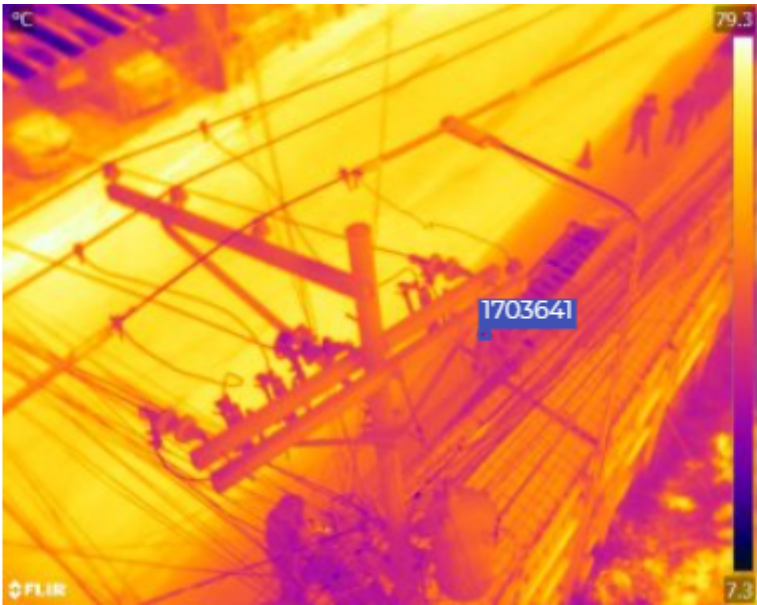
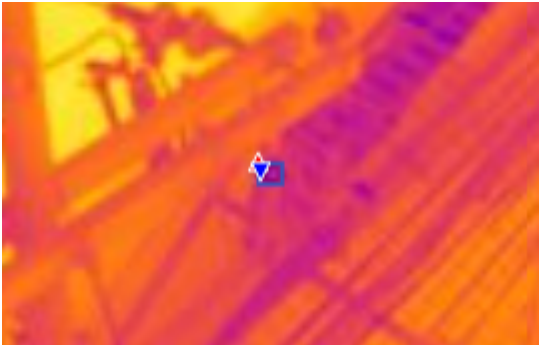
1703641 Point of interest Miscellaneous

**Thermal readings:**  
~Avg : 30.990° Δ : 29.254° ▲: 43.923° ▼: 14.669°

**Phil Lewis:**  
not sure. Visually inspect

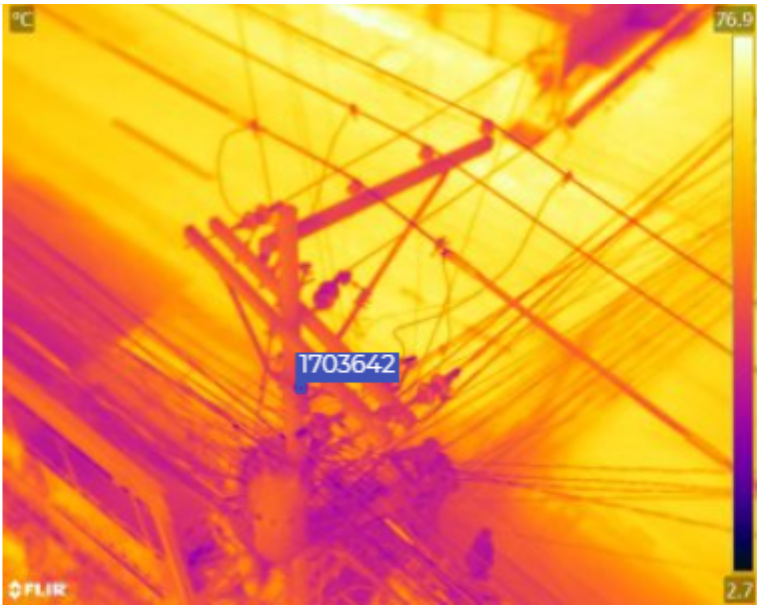
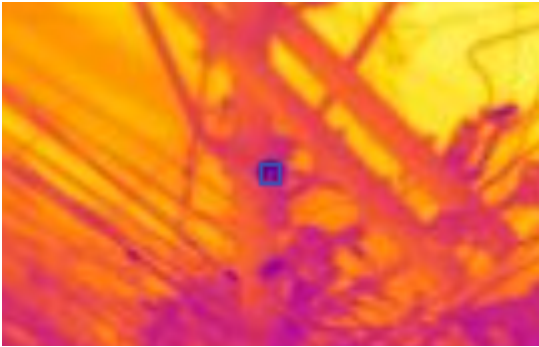
1703642 Point of interest Miscellaneous

**Phil Lewis:**  
unknown, visually inspect

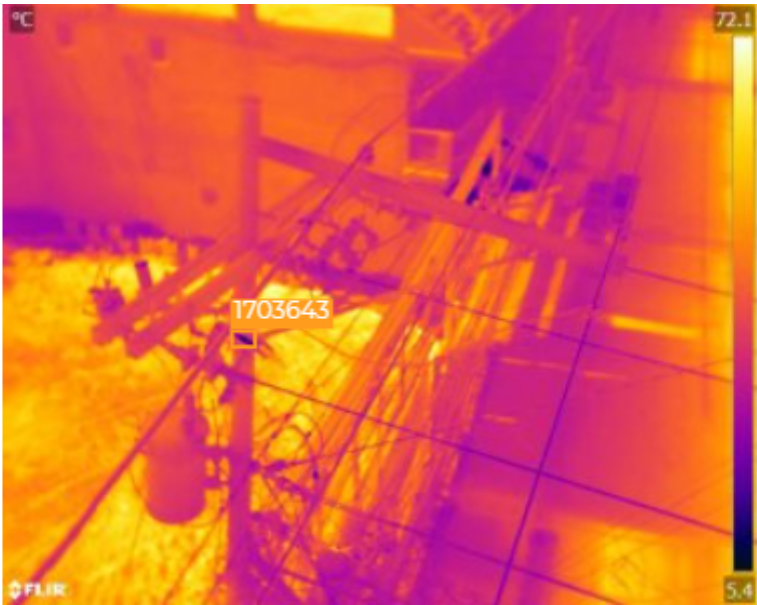
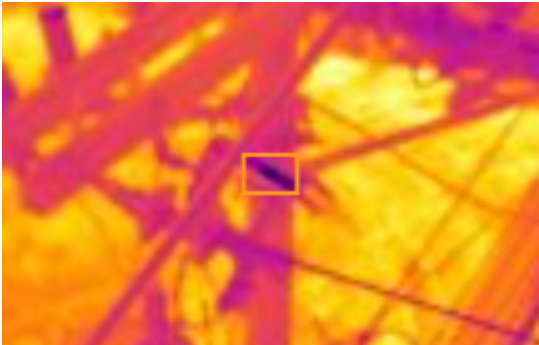
1703643 Severity: 1 Miscellaneous

**Remedy action:**  
inspect
