THE FUTURE OF VISUAL INSPECTIONS

Type:  
**Power Line**

Company:  
**Scopito Demo 1**

Inspection created:  
**Aug 15, 2019**

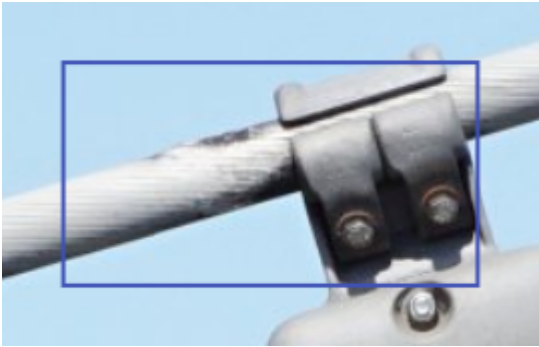
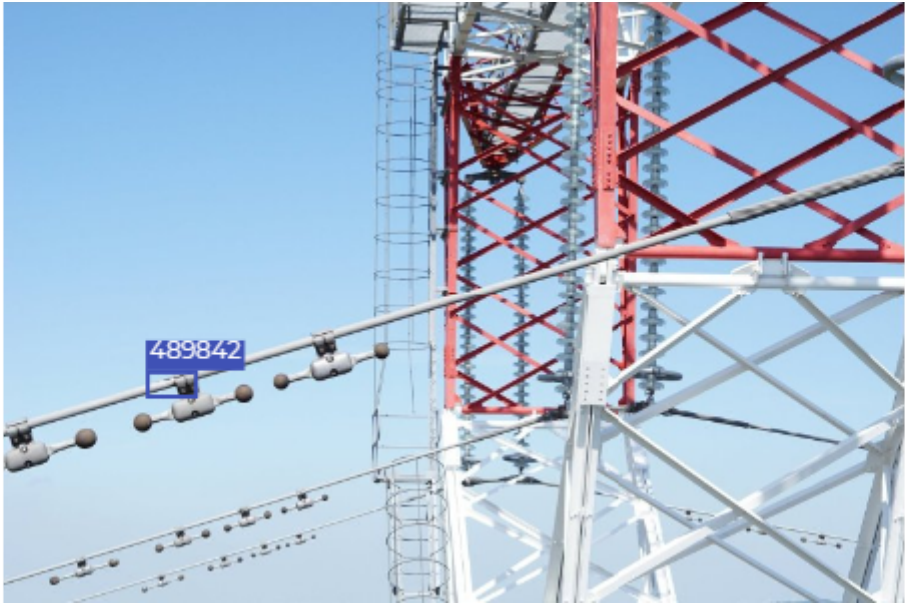
489842 Point of interest POI

**Inspector:**  
Wear from vibration damper clamps

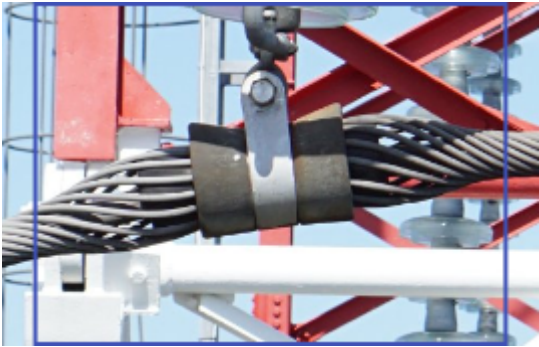
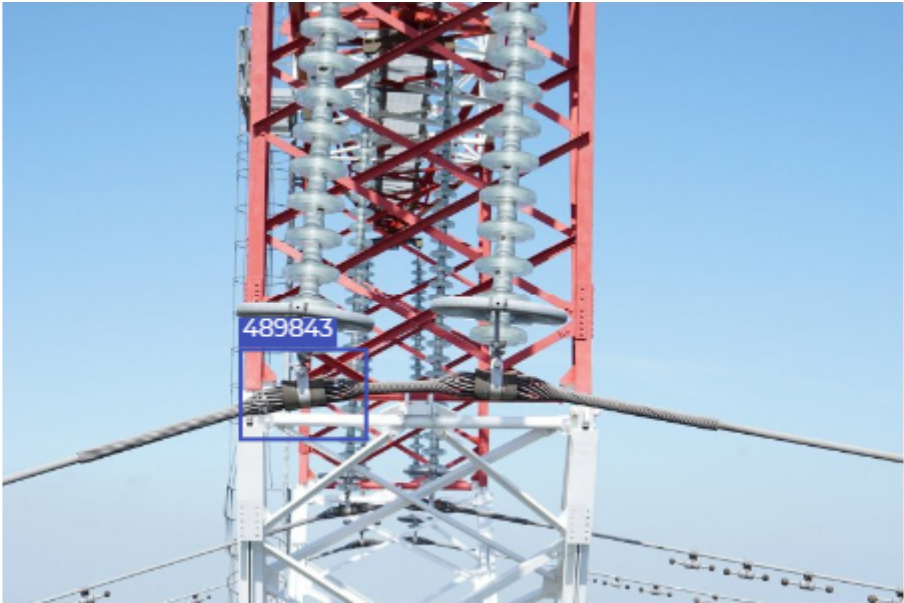
489843 Point of interest POI

Inspector:  
AGS Clamp

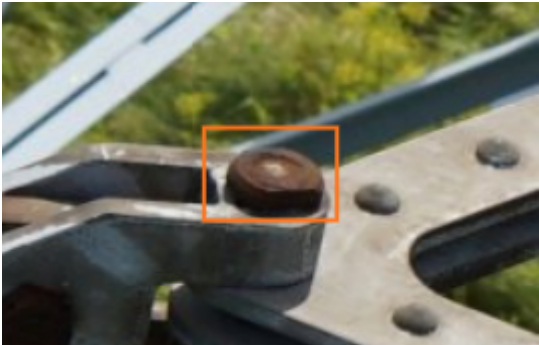
489851 Severity: 2 rust on bolt

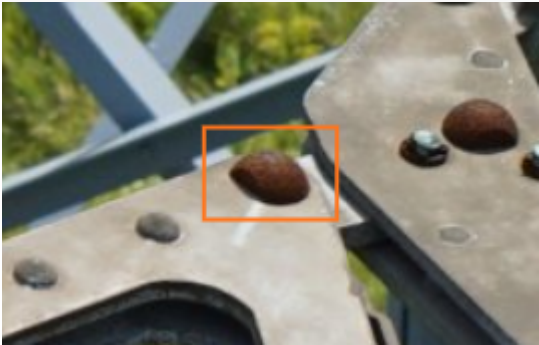
489852 Severity: 2 rust on bolt

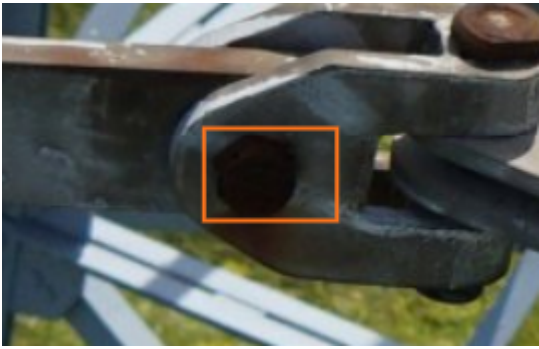
489853 Severity: 2 rust on bolt

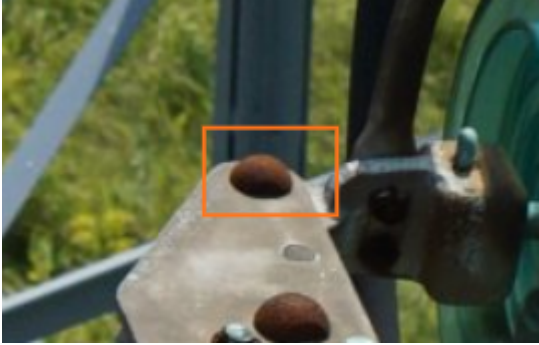
489854 Severity: 2 rust on bolt

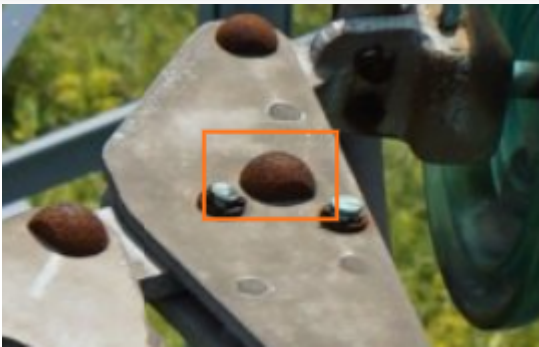
489855 Severity: 2 rust on bolt

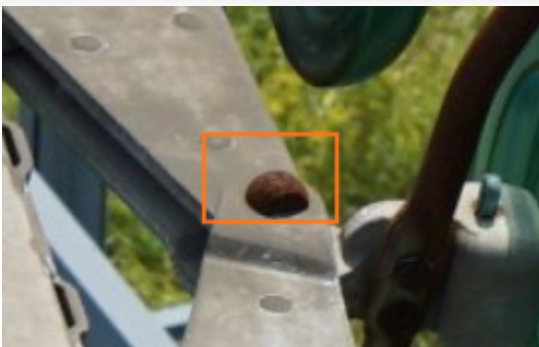
489856 Severity: 2 rust on bolt

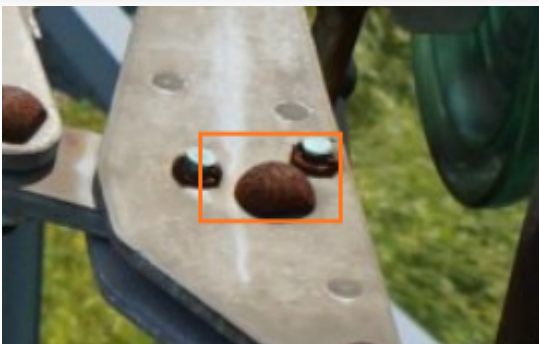
489857 Severity: 2 rust on bolt

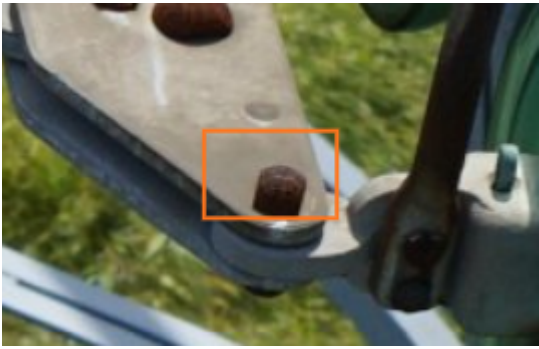
489858 Severity: 2 rust on bolt

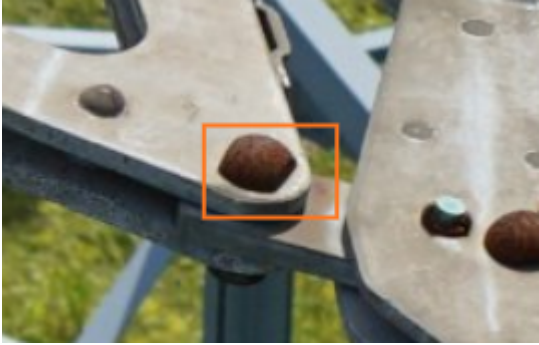
489859 Severity: 2 rust on bolt

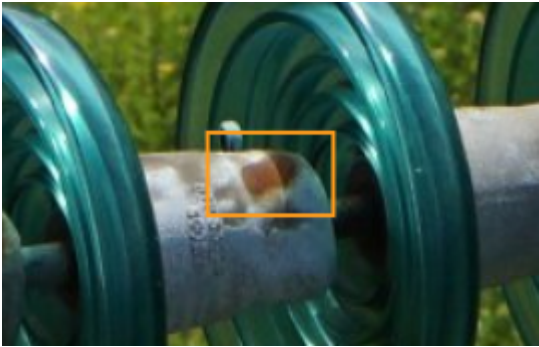
489844   Severity: 1   Rust

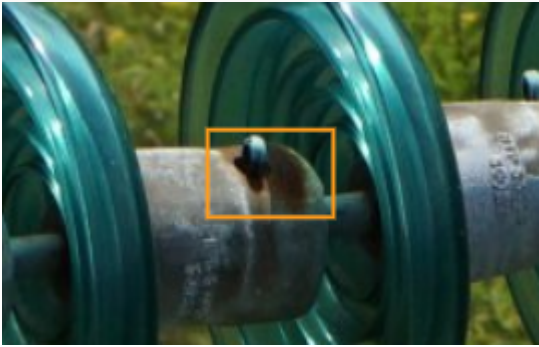
489845   Severity: 1   Rust

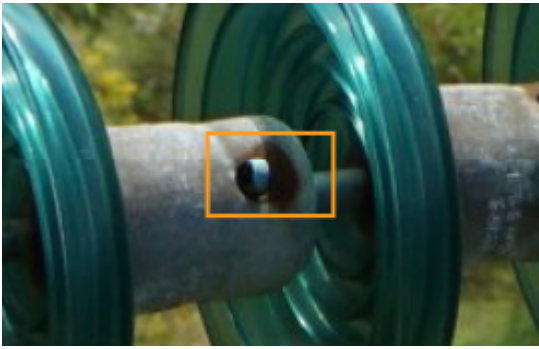
489846 Severity: 1 Rust

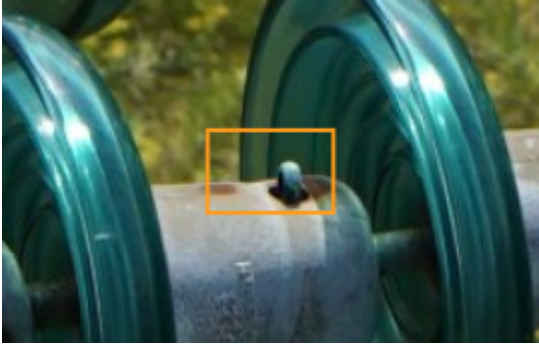
489847 Severity: 1 Rust

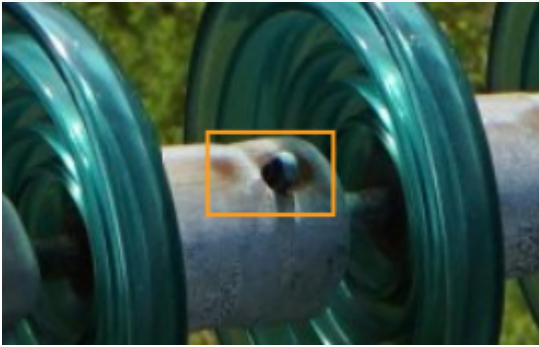
489848 Severity: 1 Rust

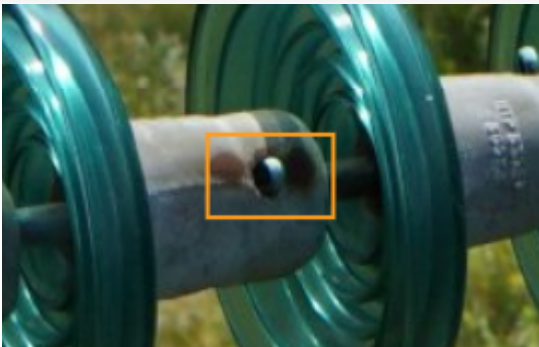
489849 Severity: 1 Rust

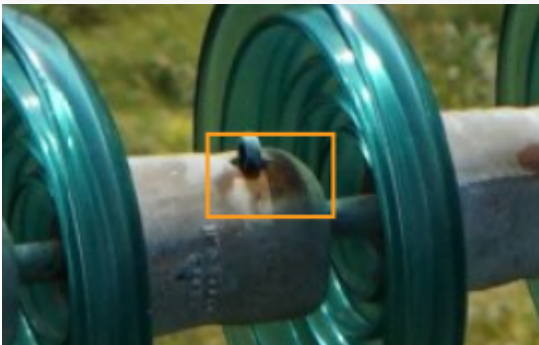
489850 Severity: 1 Rust
