Wind demo - Scopito

Drone inspection of rotor (Blades)

Date: 23-05-2018

Turbine Type: NEG Micon 2000/72 (2MW)

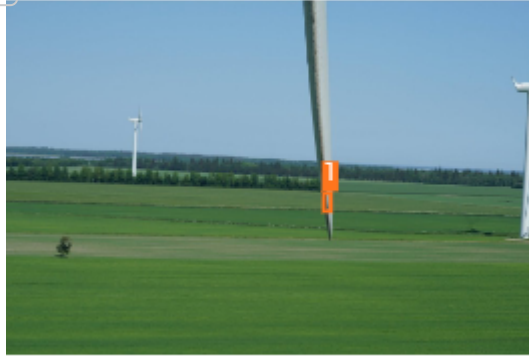
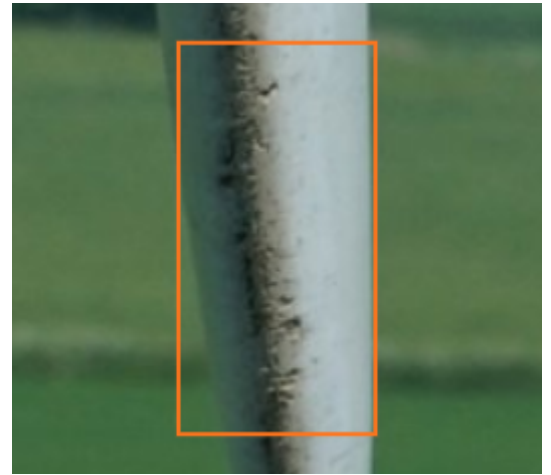
Issue Type: Erosion | Severity: 2

Distance from root: 100.0% | Size: 99mm x 197mm

Dani:
LE erosion, laminate visible

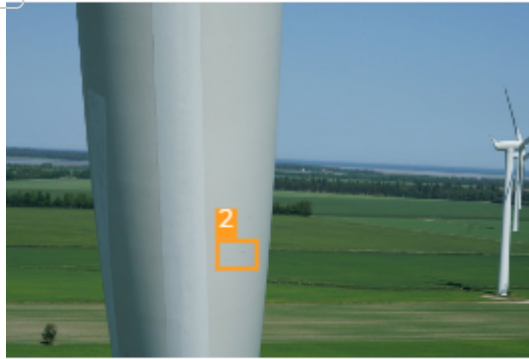
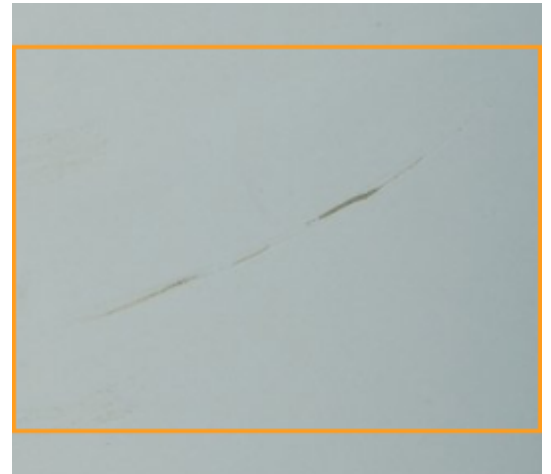
Issue Type: Damage - Gel Coat | Severity: 1

Distance from root: 14.9% | Size: 392mm x 287mm

Dani Feller:
Cosmetic damage.

Monitoring required

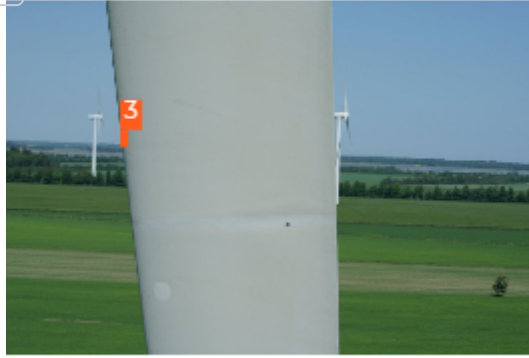
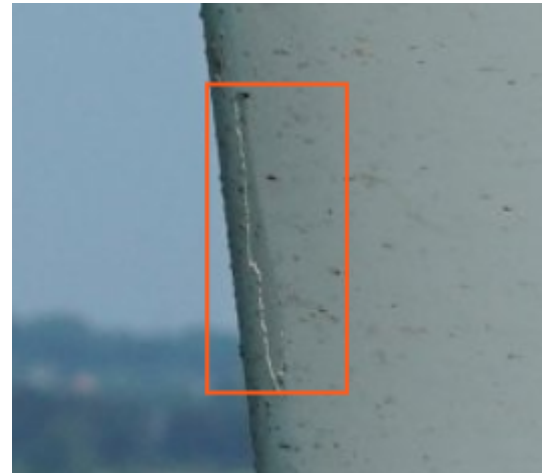
Issue Type: Erosion | Severity: 3

Distance from root: 73.7% | Size: 71mm x 156mm

Dani:
Possible Crack

further investigation needed

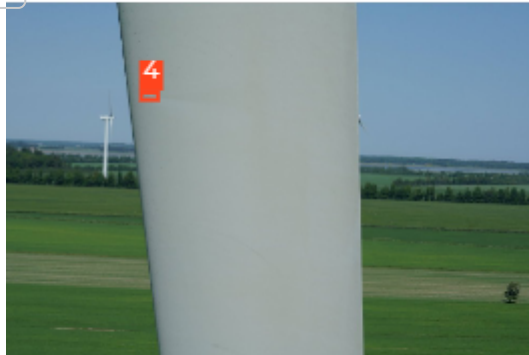
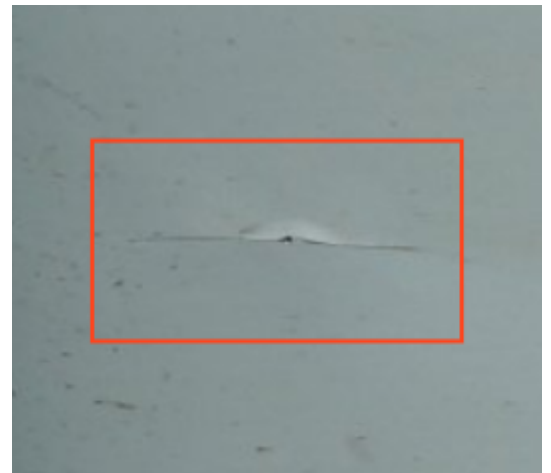
Issue Type: Crack | Severity: 4

Distance from root: 67.6% | Size: 186mm x 101mm

Dani:
Horizontal crack - possible crack in laminate.

Address this in the next visit and not later than 6 months from inspection's date.

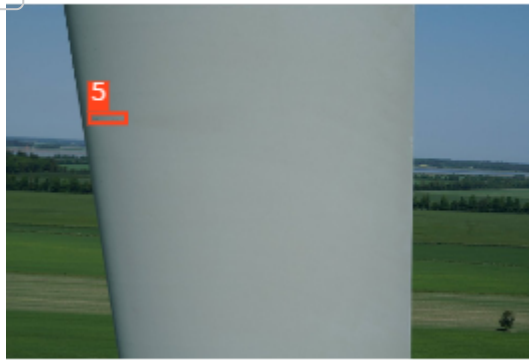
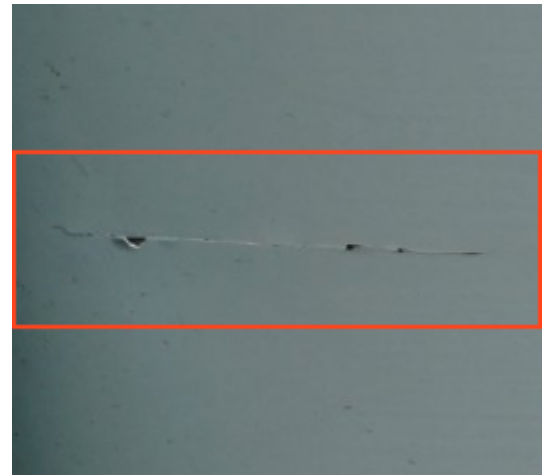
Crack

36.6%

368mm x 124mm

Dani:
Horizontal crack

Address this in the next visit and not later than 6 months from inspection's date.
