# scopito

Report date:  
Mar 16, 2020

Type:  
Power Line

Company:  
Scopito Demo 1

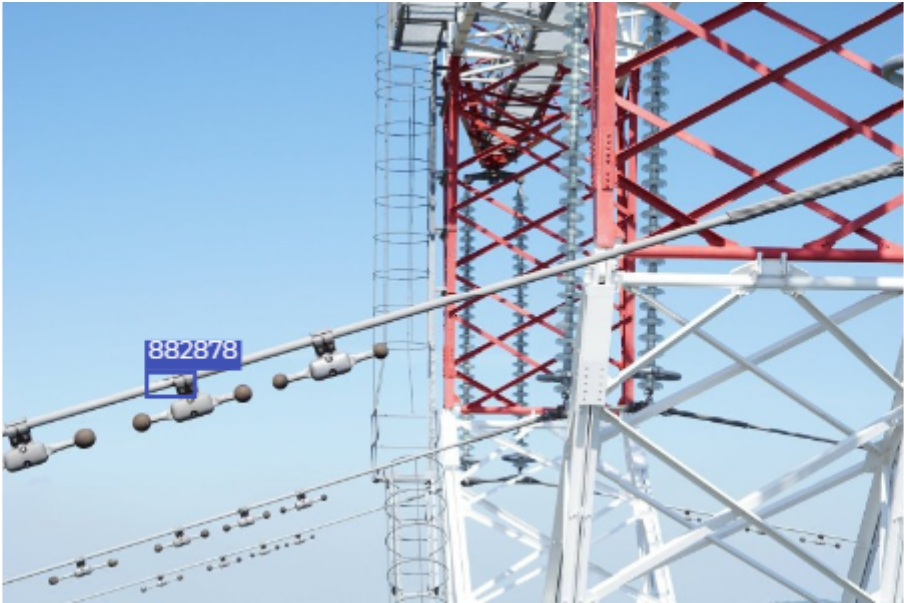
882878 Point of interest POI

**Inspector:**  
Wear from vibration damper clamps

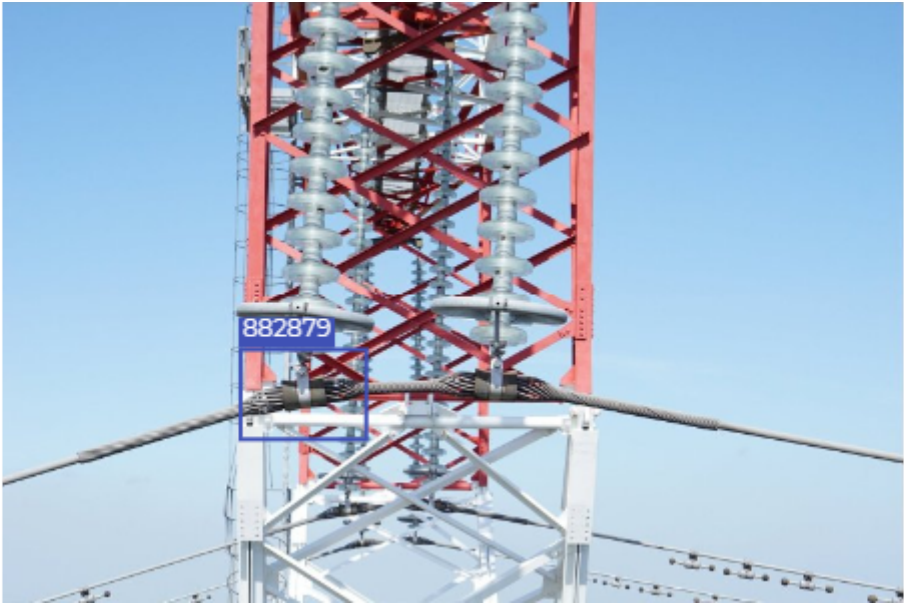
882879 Point of interest POI

Inspector:  
AGS Clamp

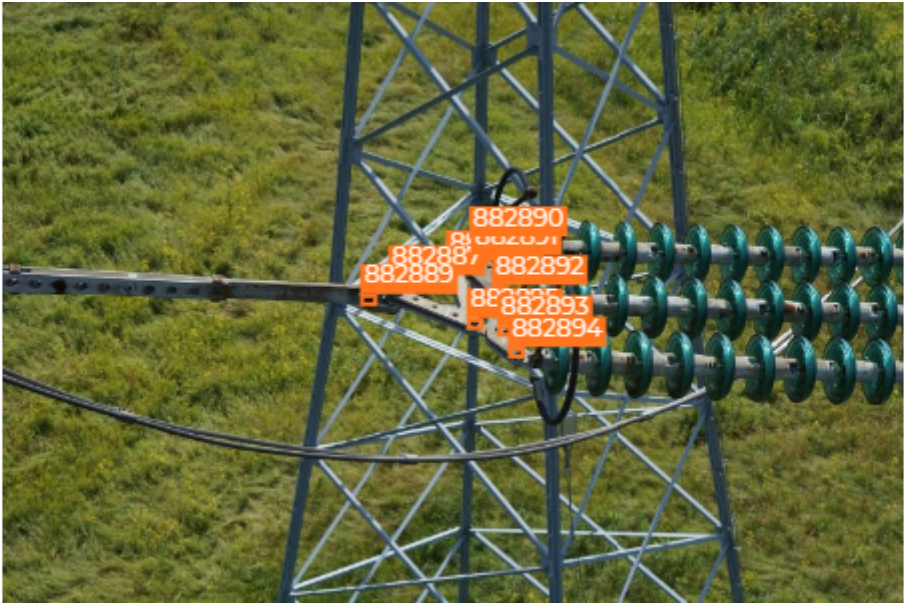
882887 Severity: 2 rust on bolt

882888 Severity: 2 rust on bolt

882889 Severity: 2 rust on bolt

882890 Severity: 2 rust on bolt

882891 Severity: 2 rust on bolt

882892 Severity: 2 rust on bolt

882893 Severity: 2 rust on bolt

882894 Severity: 2 rust on bolt

882895 Severity: 2 rust on bolt

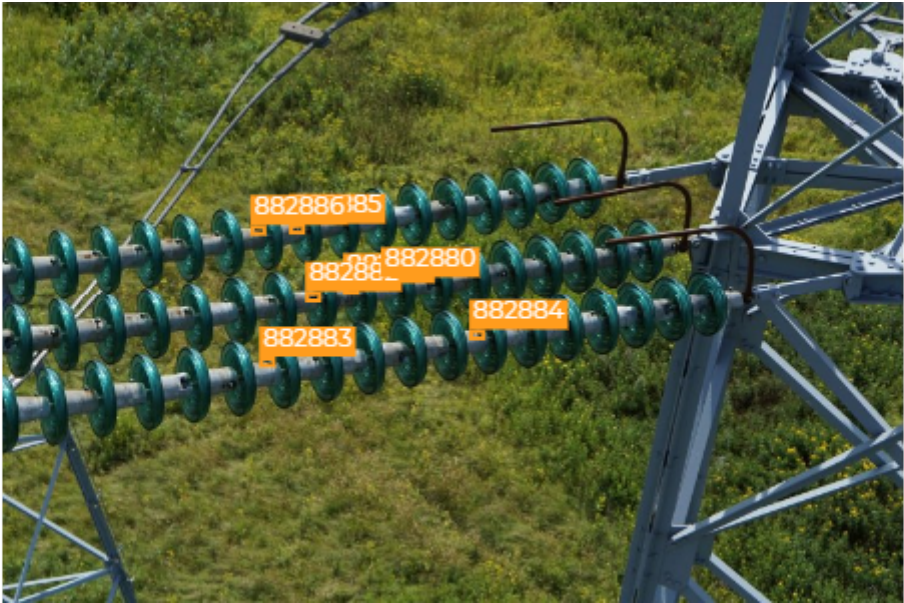
882880   Severity: 1   Rust

882881   Severity: 1   Rust

882882 Severity: 1 Rust

882883 Severity: 1 Rust

882884 Severity: 1 Rust

882885 Severity: 1 Rust

882886 Severity: 1 Rust
