THE FUTURE OF VISUAL INSPECTIONS

Type:  
**Power Line**

Company:  
**Scopito Demo 1**

Inspection created:  
**Aug 15, 2019**

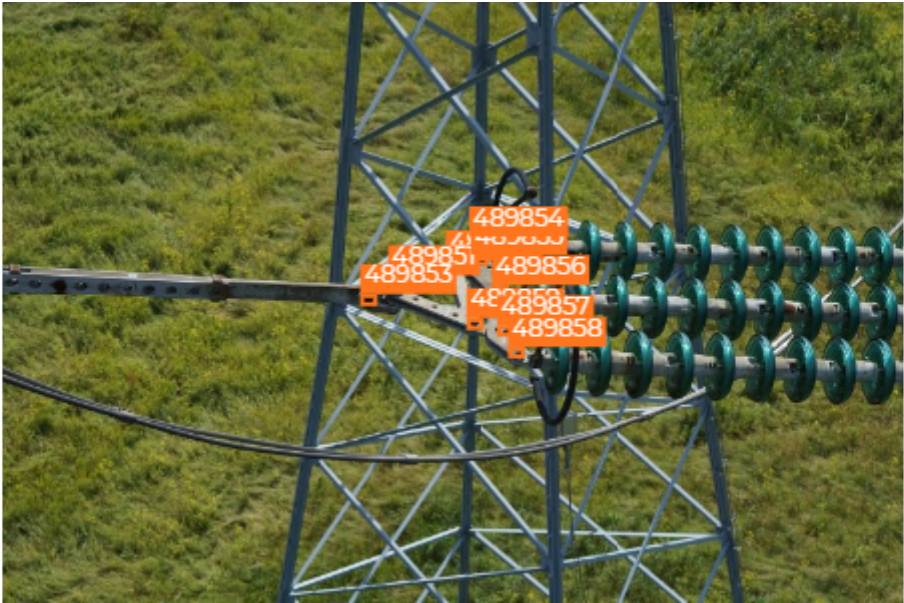
| File name: | DSC00020.JPG | Altitude: | 26.73m |

489851 Severity: 2 rust on bolt

489852 Severity: 2 rust on bolt

489853 Severity: 2 rust on bolt

489854 Severity: 2 rust on bolt

489855 Severity: 2 rust on bolt

489856 Severity: 2 rust on bolt

489857 Severity: 2 rust on bolt

489858 Severity: 2 rust on bolt

489859 Severity: 2 rust on bolt

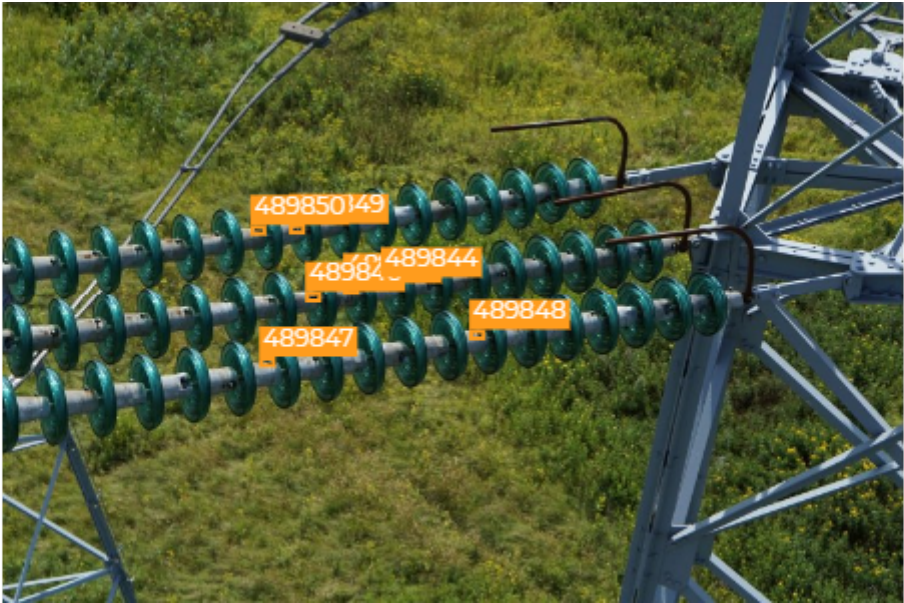
| File name: | DSC00023.JPG | Altitude: | 25.64m |

489844   Severity: 1   Rust

489845   Severity: 1   Rust

489846 Severity: 1 Rust

489847 Severity: 1 Rust

489848 Severity: 1 Rust

489849 Severity: 1 Rust

489850 Severity: 1 Rust

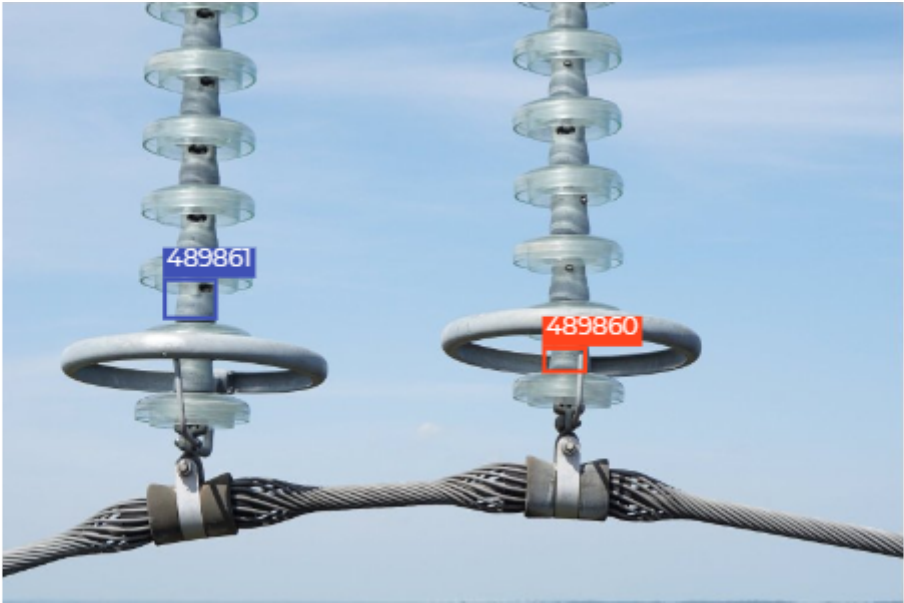
| File name: | DSC00012.JPG | Altitude: | 82.42m |

| Id | Severity | Issues | Comments | Page |
|---|---|---|---|---|
| 489860 | 4 | POI | Check here | 11 |
| 489861 | ? | ID# | Visible | 11 |
